Site Assessment

Hereford Point

Roman Road, Hereford HR4 9QP

Reviewed - 21-08-2024

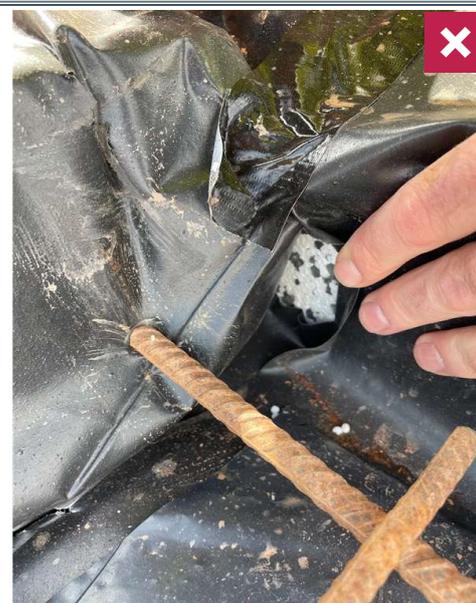
2) Plot No(s): 492

- Laps to the membrane were not sealed as per the design/manufacture's requirements.
- The corners of the DPM were not adequately sealed.

A new gang of groundworkers did not fully understand what they were trying to achieve when sealing the DPM. They believed they were sealing the membrane correctly. However, gaps existed in multiple locations where the seals were not continuous at complicated or difficult-to-form junctions.
