Site Assessment

Hereford Point

Roman Road, Hereford HR4 9QP

Reviewed - 21-08-2024

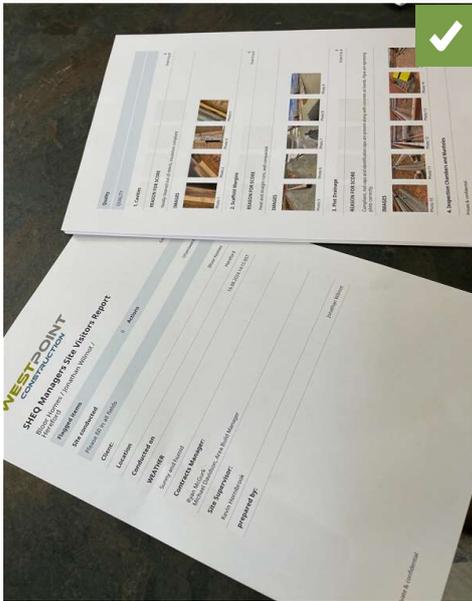
1) Plot No(s): QC documentation

- Quality control documentation was completed and viewed.
- Drawings and details were available to view on site.
- Placement of concrete was accurate with minimal overspill.
- Excavation corners were neatly formed.
- The concrete finish was consistent in texture and appearance.
- Setting out pins/paint were used to achieve line and level.
- Task specific funnel bucket used to avoid concrete overspill.

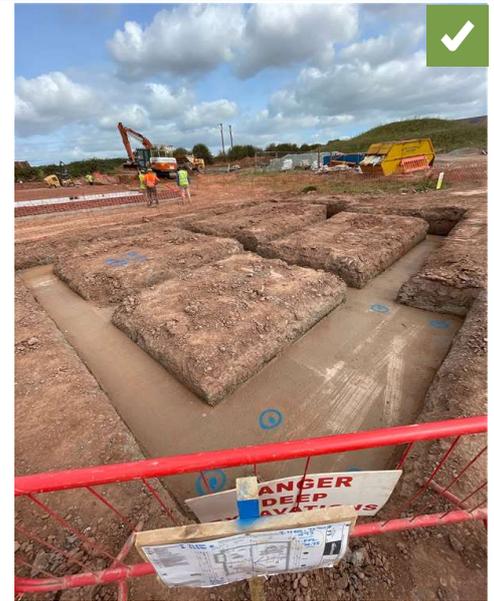
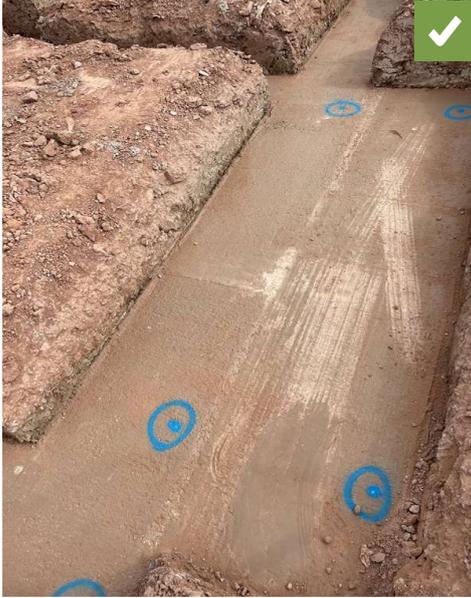
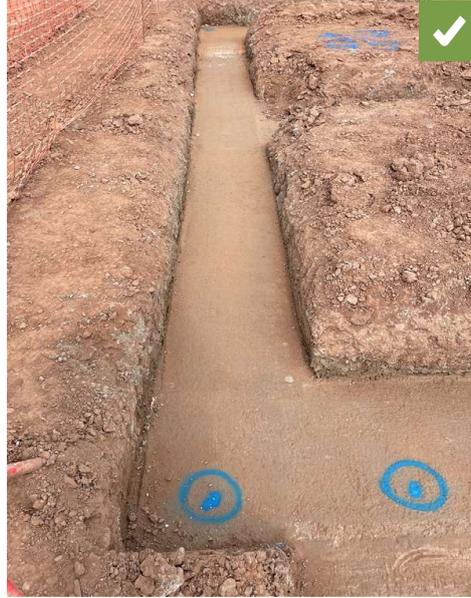
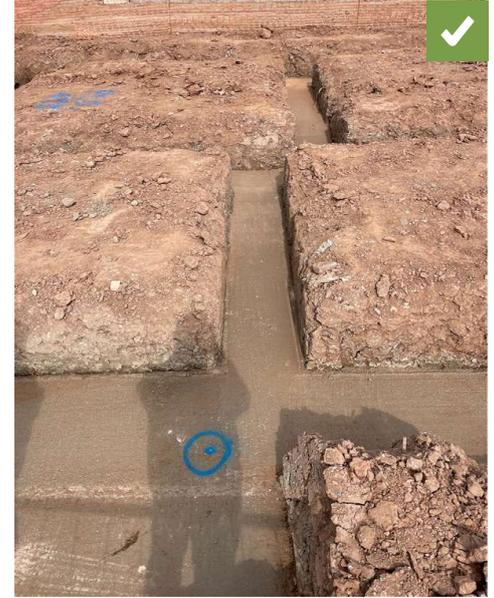
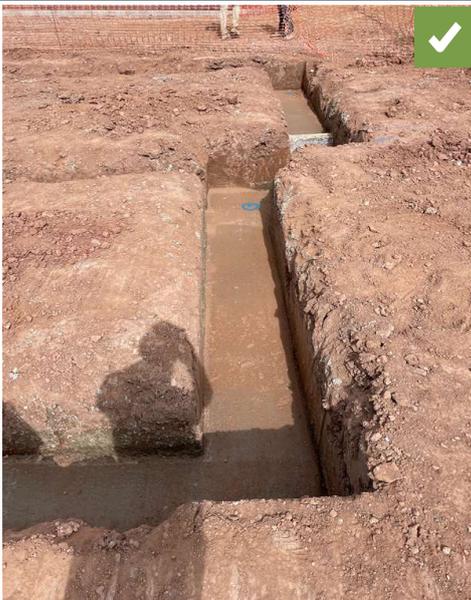
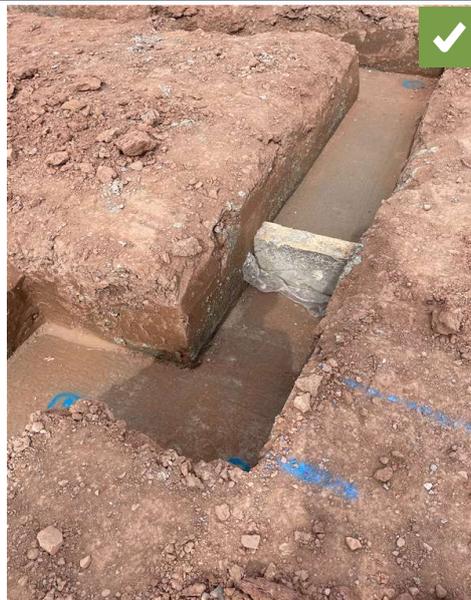
- 1 plot was available and viewed at this build stage, plot 493.
- Component/product/material details: Foundations / Trench fill / concrete placement.
- Contractor details: Westpoint (Groundwork contractors).
- Quality was very good and consistent across the plot seen.

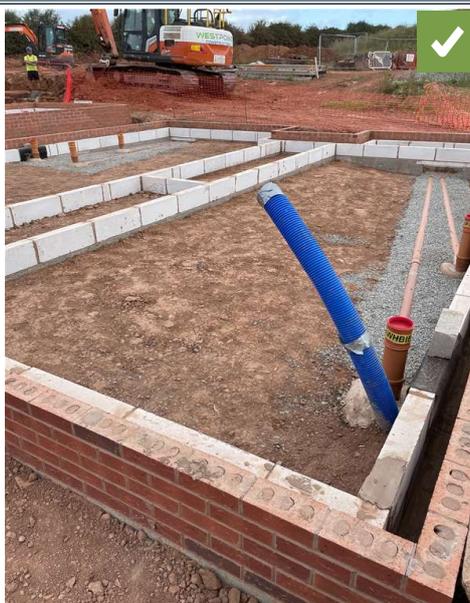
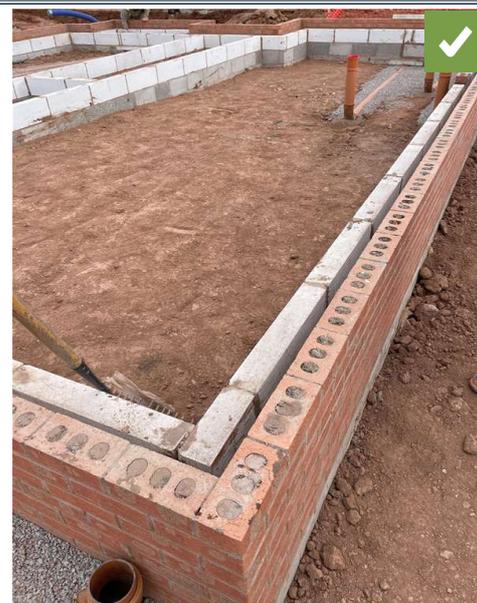
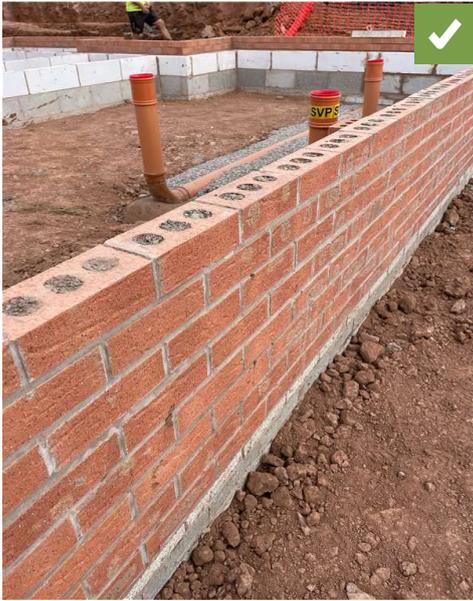
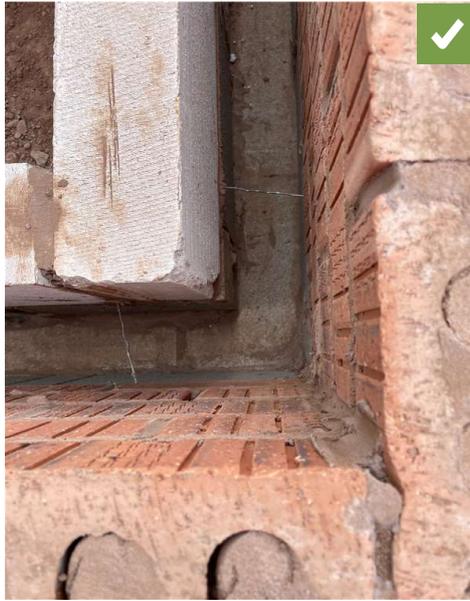
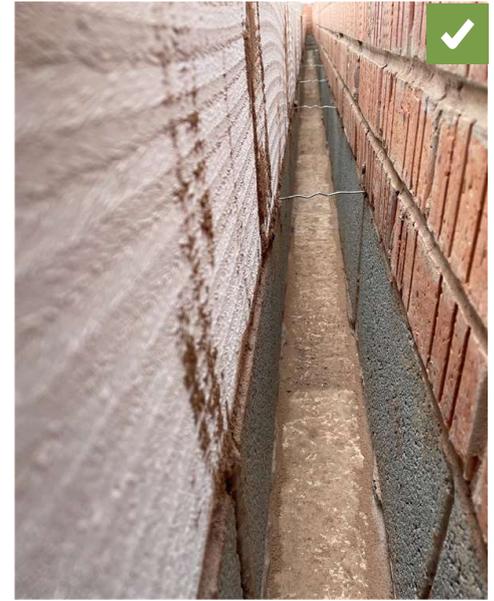
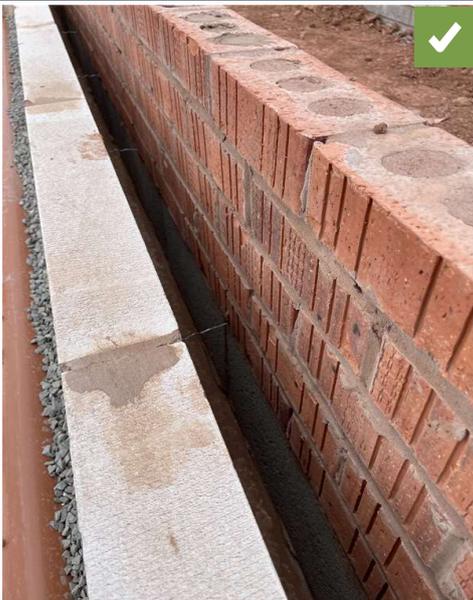
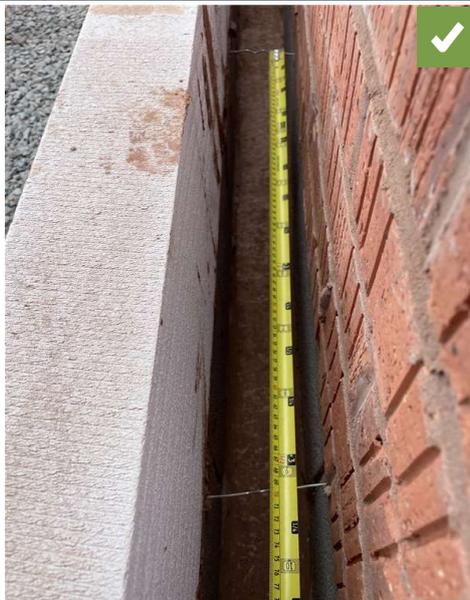
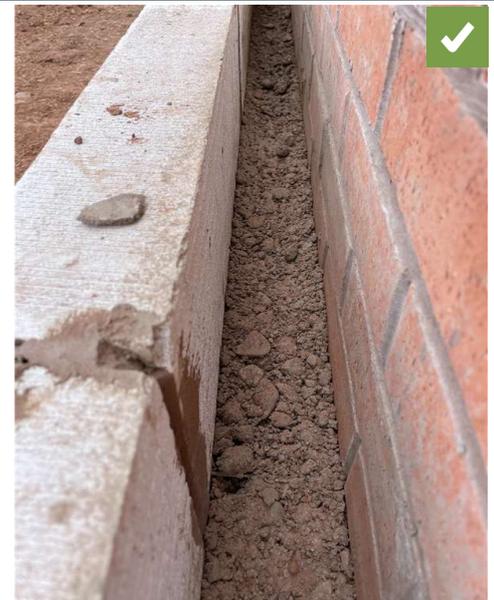
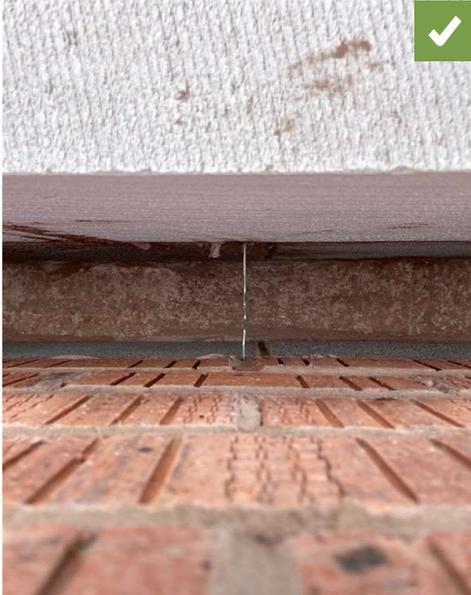
- Multiple plots were available with 2 viewed at this build stage, plots 494 & 495.
- Component/product/material details: Foundation blockwork / Splash course / Cavities.
- Contractor details: Westpoint (Groundwork contractors).
- Quality was very good and consistent across the plots seen.

- Quality control documentation was completed and viewed.
- A good line and level to the masonry had been achieved.
- Bed and perp joints were fully filled.
- Bond was correctly maintained.
- Frogs in the brickwork were filled with mortar.
- The cavities viewed were clean and free from debris.
- The internal face of the masonry was pointed.
- Wall ties were correctly spaced not exceeding 900mm horizontally.
- Cavity infill was neatly placed and chamfered to the outside face.
- Wall ties were at 90 degrees to the face of the masonry.

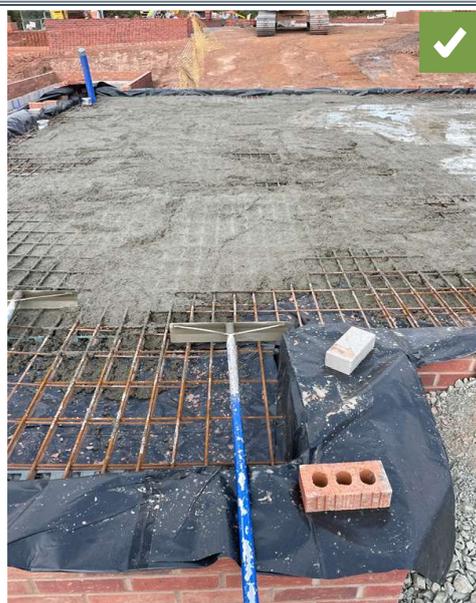
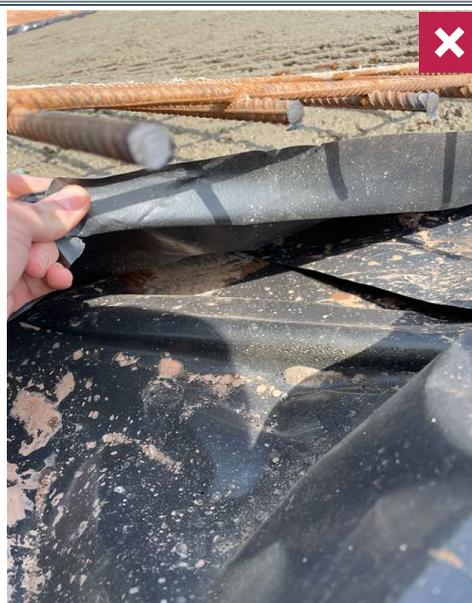
- Laps to the membrane were not sealed as per the design/manufacture's requirements.
- The corners of the DPM were not adequately sealed.

A new gang of groundworkers did not fully understand what they were trying to achieve when sealing the DPM. They believed they were sealing the membrane correctly. However, gaps existed in multiple locations where the seals were not continuous at complicated or difficult-to-form junctions.

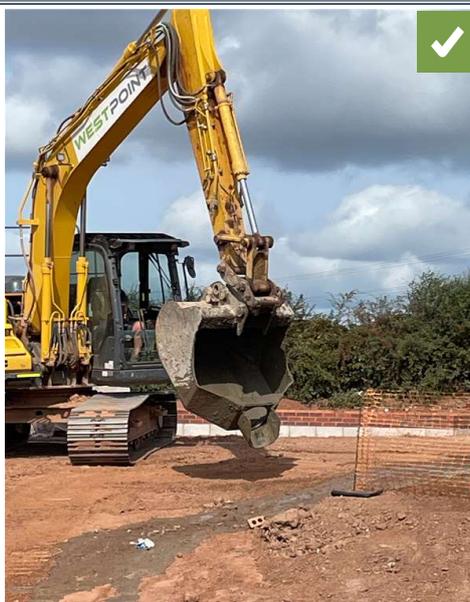
2) Plot No(s): Funnel bucket

- Quality control documentation was completed and viewed.
- Task specific funnel bucket used to avoid concrete overspill.
- 40mm minimum cover to reinforcement achieved where using a DPM.
- Reinforcement and mesh were appropriately supported, overlapped, and secured.
- The completed floor was level with a suitable finish.
- Thermal break had been provided to doorways.
- Thermal break had been provided to perimeter of floor.

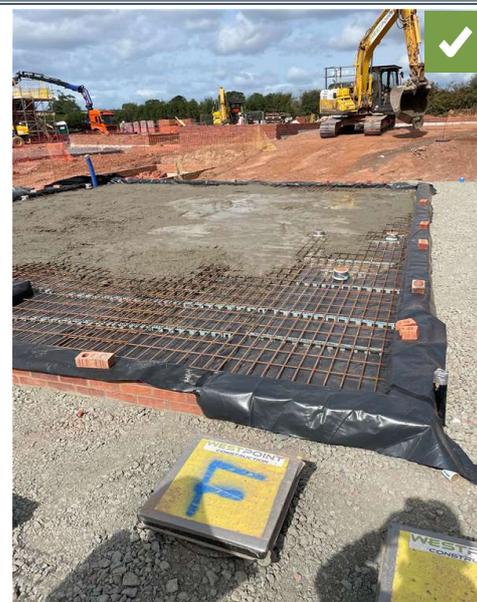
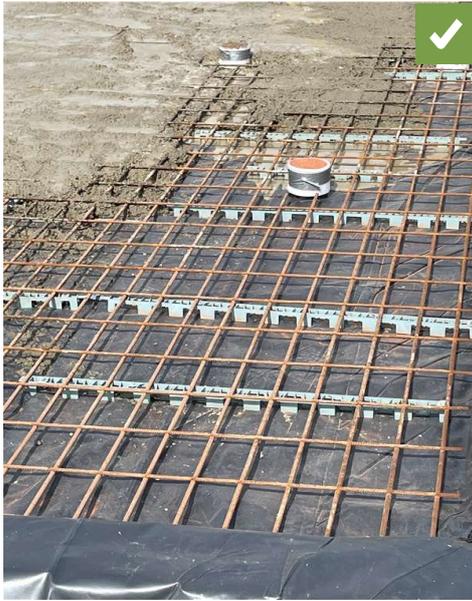
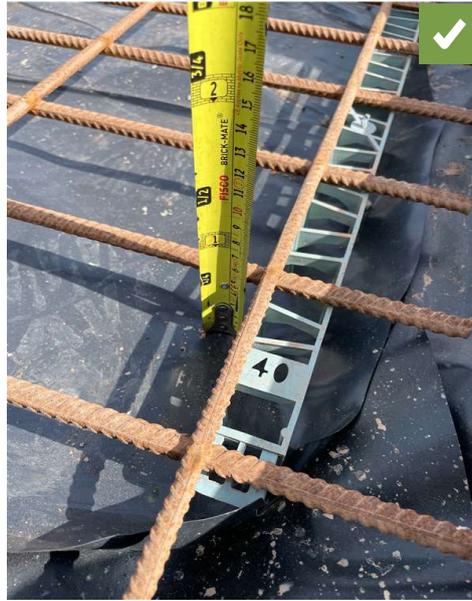
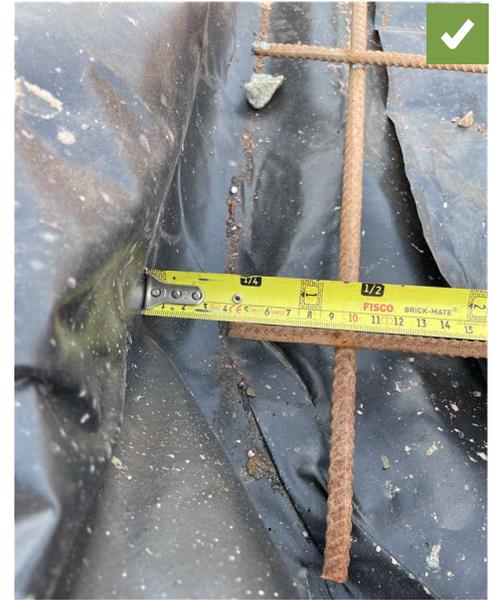
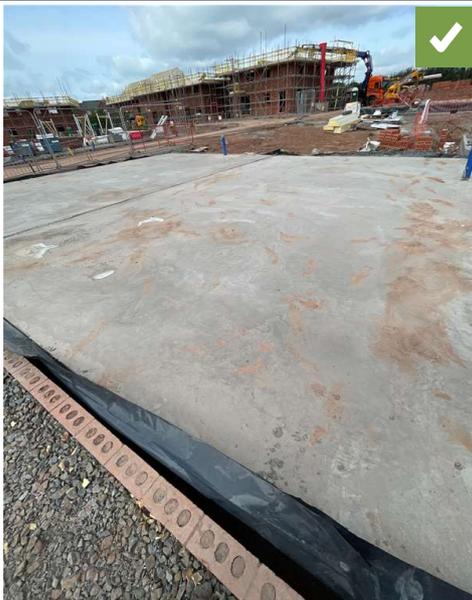
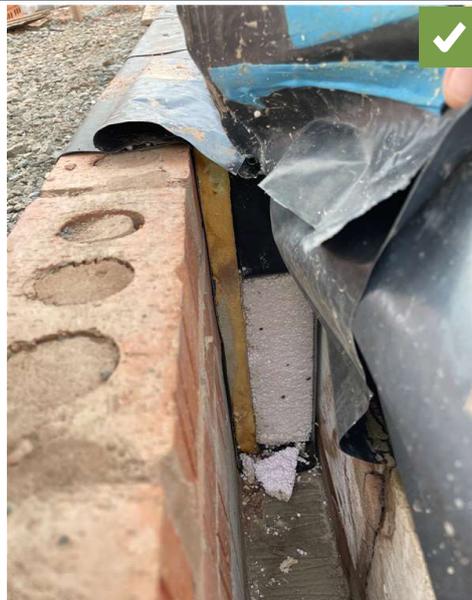
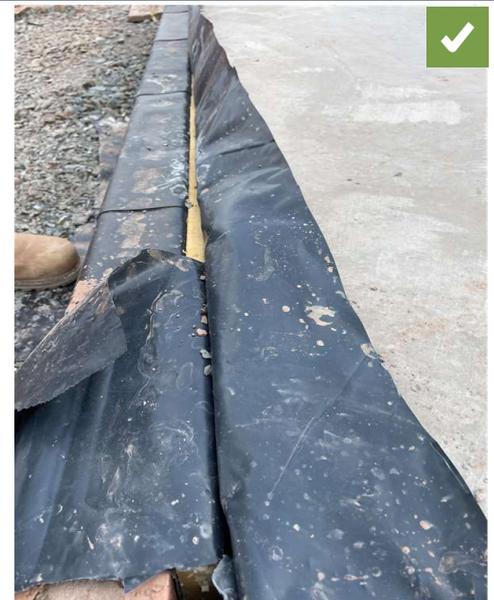
- Multiple plots were available with 3 viewed at this build stage, plots 489-490 & 492.
- Component/product/material details: Suspended ground floor / cast-in-situ / Insulation.
- Contractor details: Westpoint (Groundwork contractors).
- Quality was good and consistent across the plots seen.

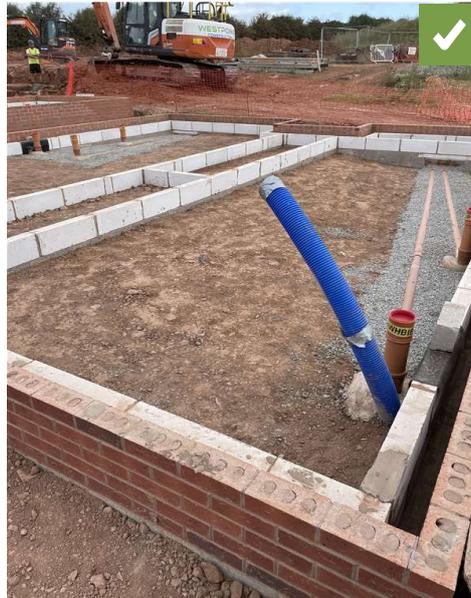
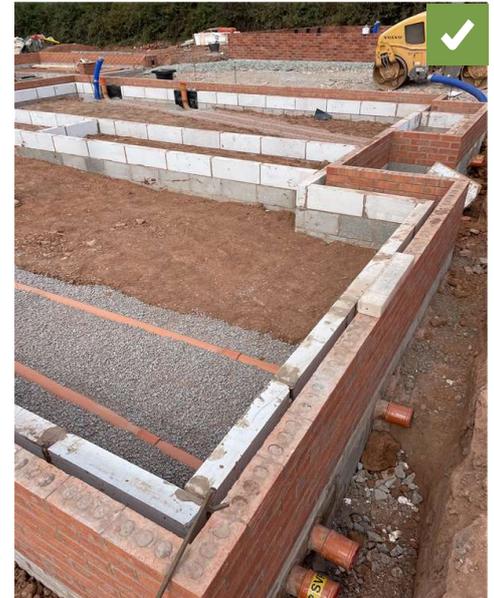
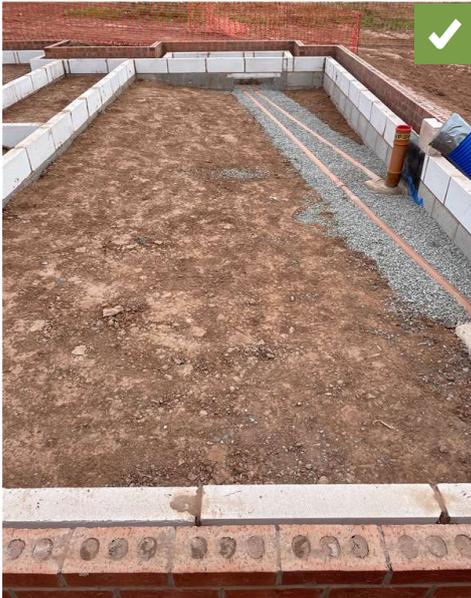
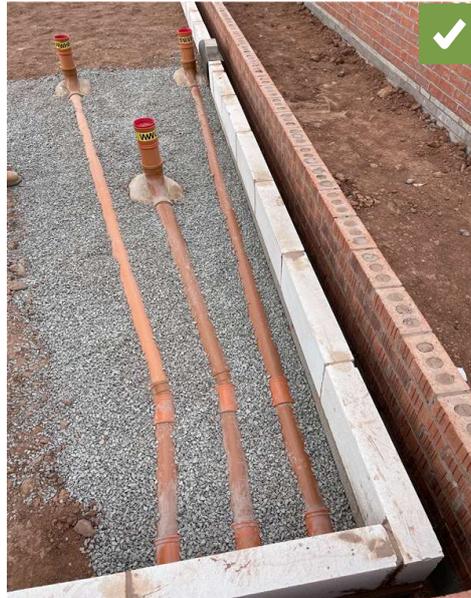
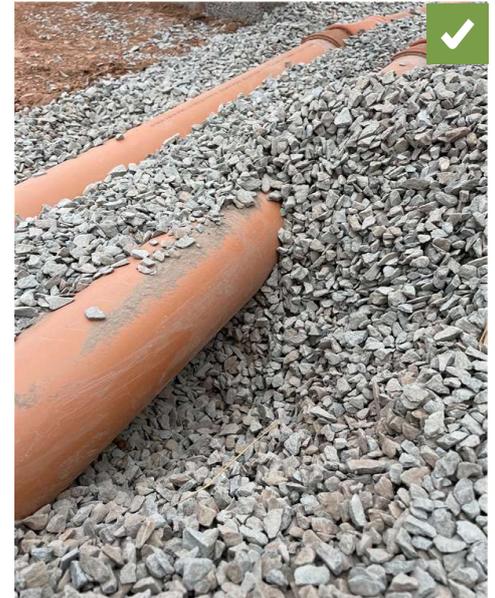
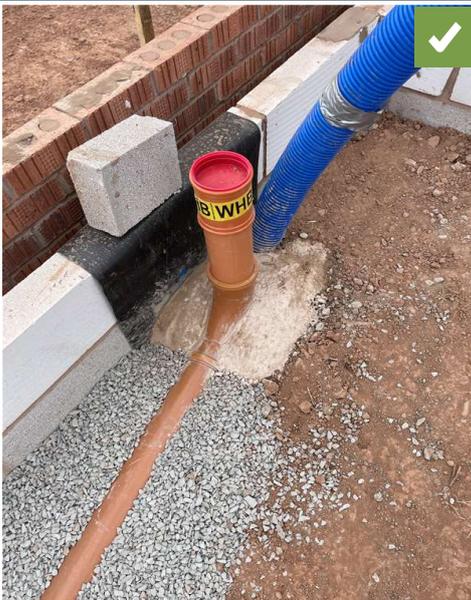
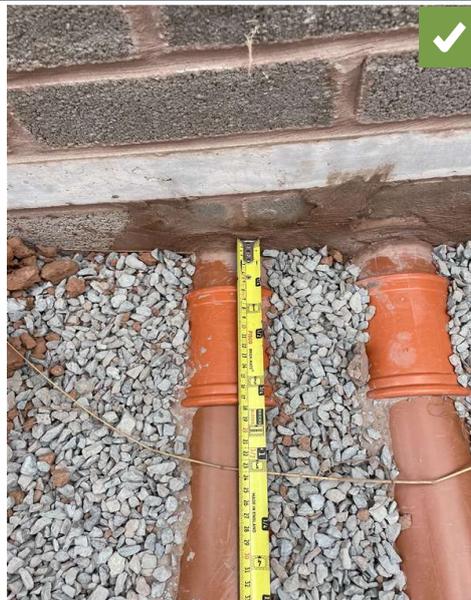
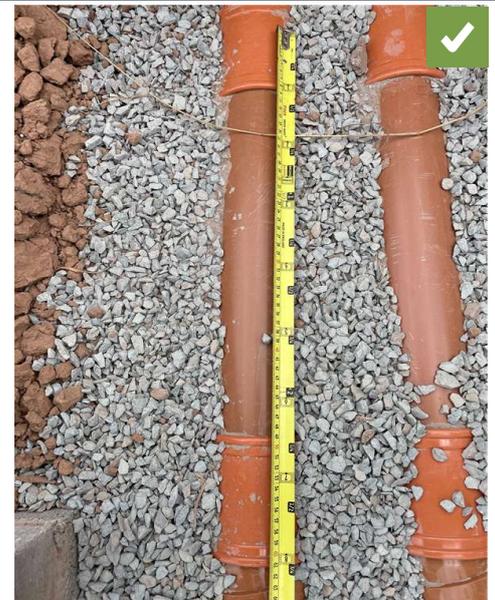
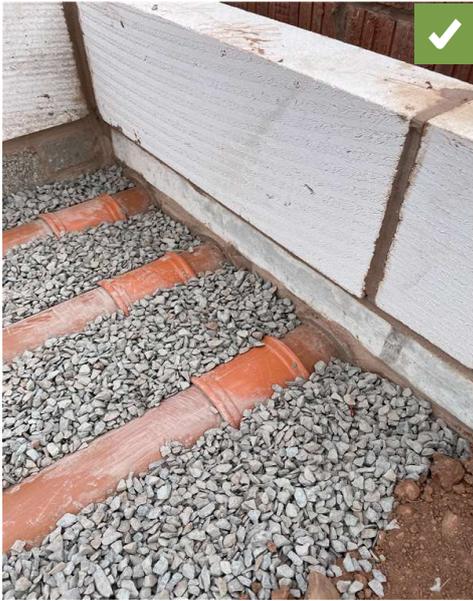
- Multiple plots were available with 2 viewed at this build stage, plots 494 & 495.
- Component/product/material details: Subfloor drainage / Inspection chambers.
- Contractor details: Westpoint (Groundwork contractors).
- Quality was outstanding and consistent across the plots seen.

- Good presentation of the completed works was achieved without the wastage of imported materials (ie. Sand).
- All open ends of drainage were capped off.
- All pipe runs were clearly labelled.
- Support of pipework had been provided with appropriate falls.
- The granular bedding to support drainage was a minimum of 100mm in depth.
- Support had been provided to internal rest bends.
- DPC was installed as a slip plane between the concrete, walls and other pipes to mitigate heave or ground movement.
- Flexible joints were installed, ensuring centres to collars were within 150mm of the wall and 600mm of the first collar.
- Penetrations had been closed to prevent vermin entry.

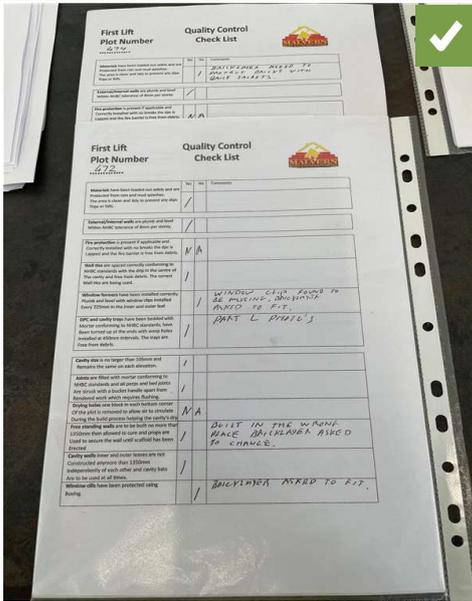
1) Plot No(s): QC documentation

- Quality control documentation was completed and viewed.
- A good line and level to the blockwork was achieved.
- Bed and perp joints had been pointed.
- Bed and perp joints were even and fully filled.
- Coursing blocks were installed to achieve correct setting out.
- Blocks between joist were neatly cut and pointed.
- The cavity side of the block work had been neatly pointed.

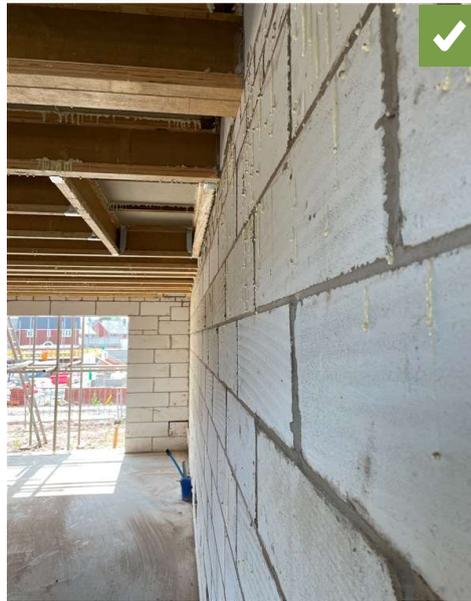
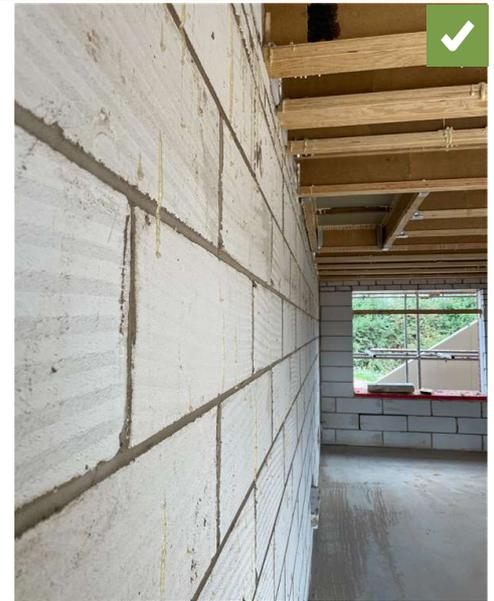
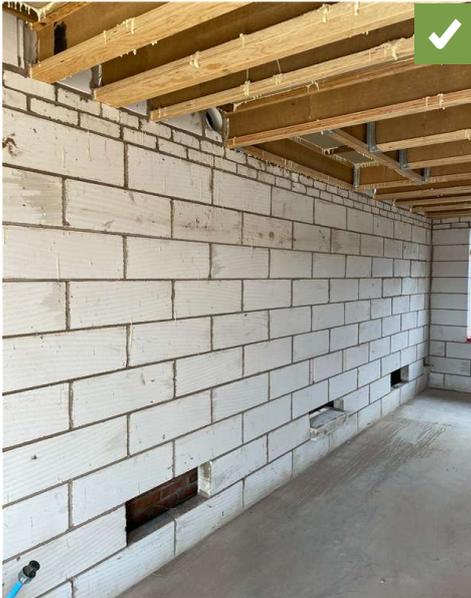
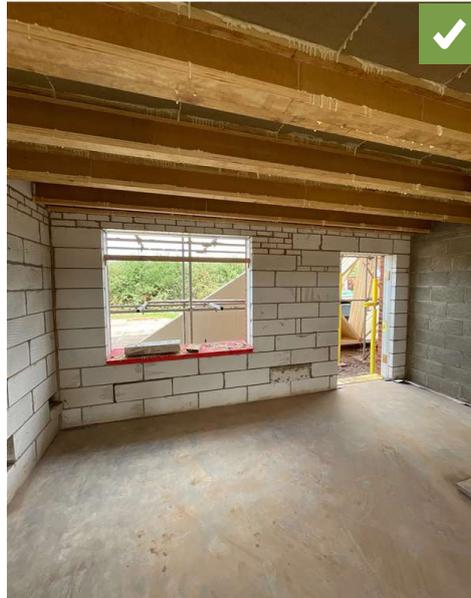
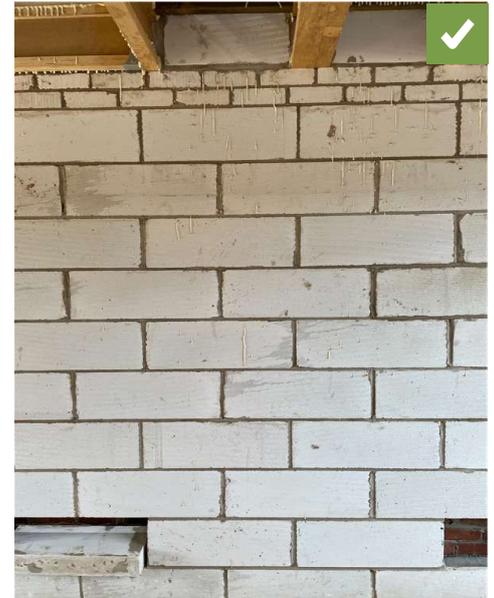
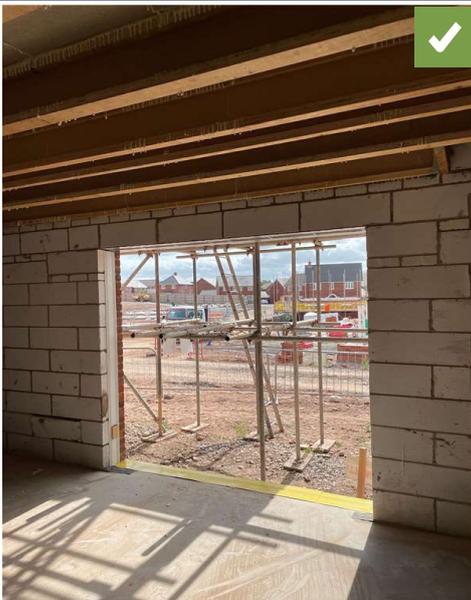
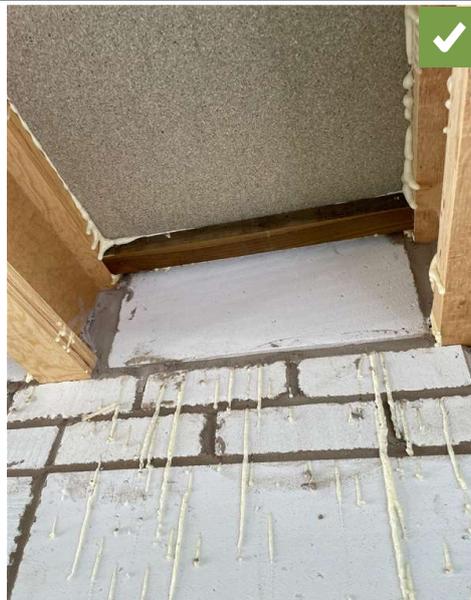
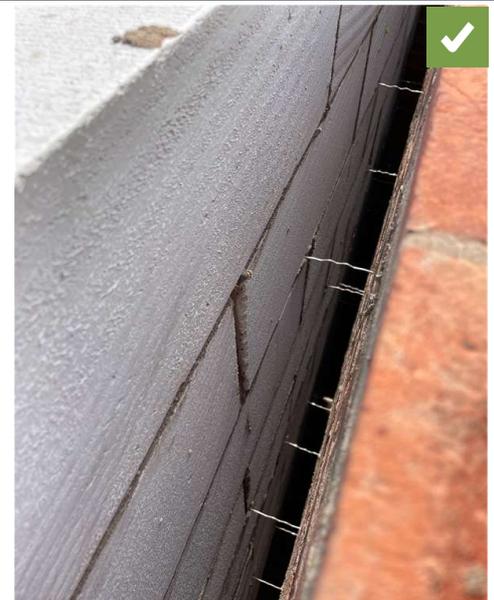
- Multiple plots were available with 1 viewed at this build stage, plot 482.
- Component/product/material details: Traditional cavity wall / Inner leaf blockwork (Aircrete).
- Contractor details: Malvern Brickwork (Bricklaying contractor).
- Quality was very good and consistent across the plot seen.

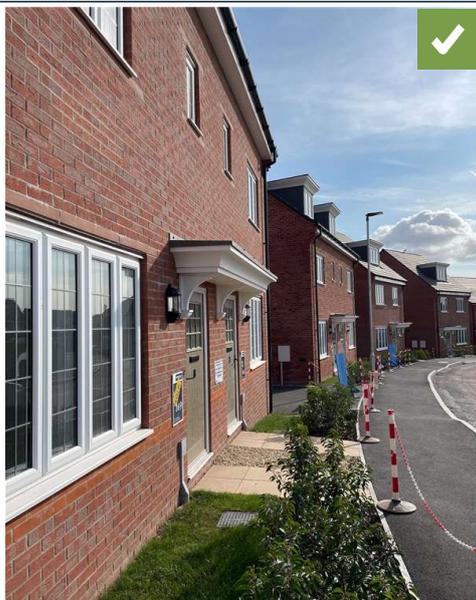
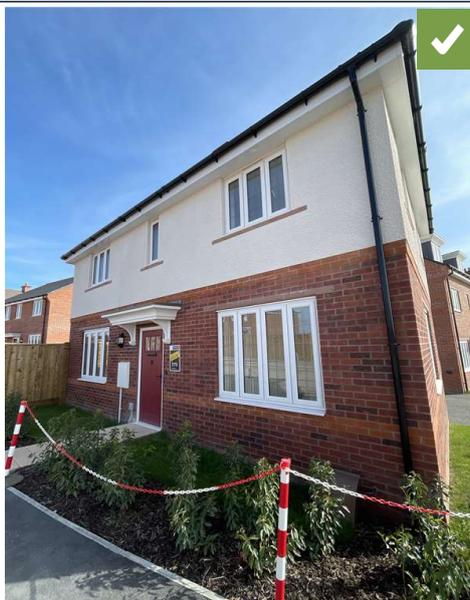
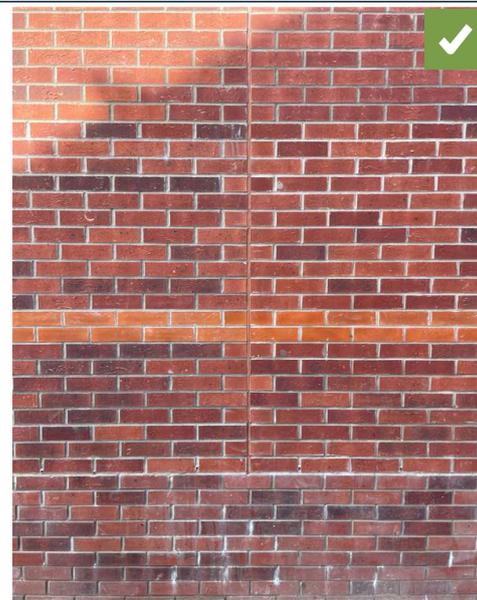
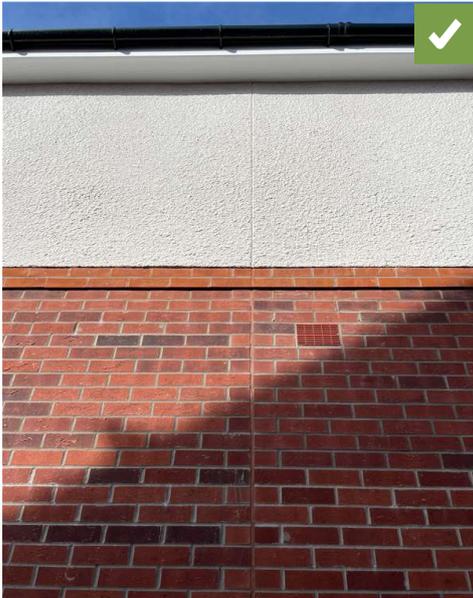
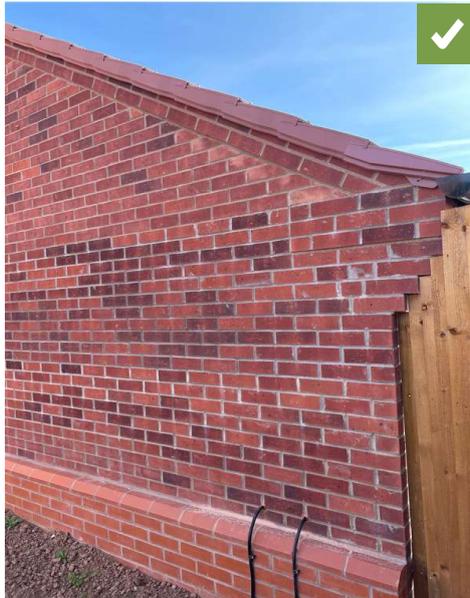
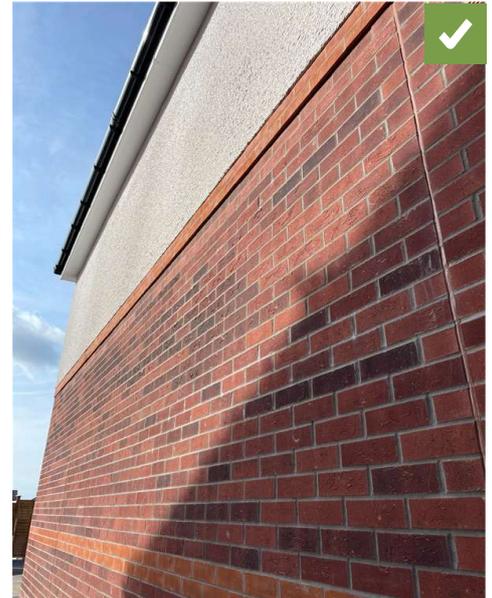
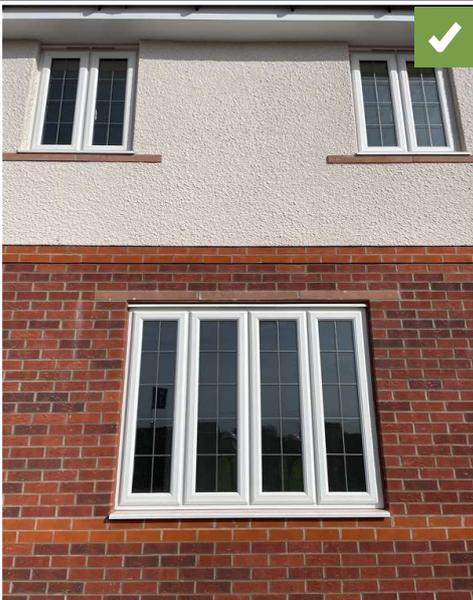
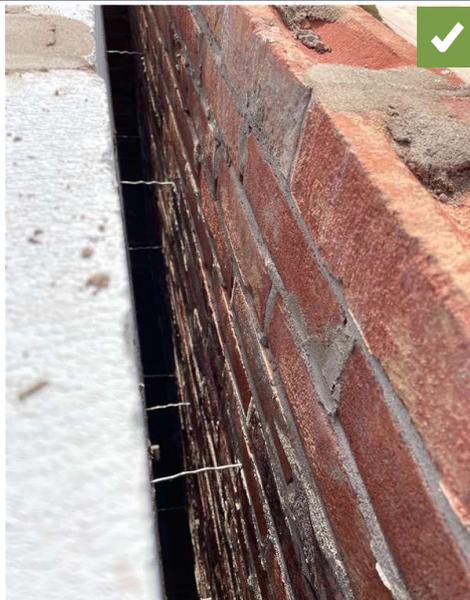
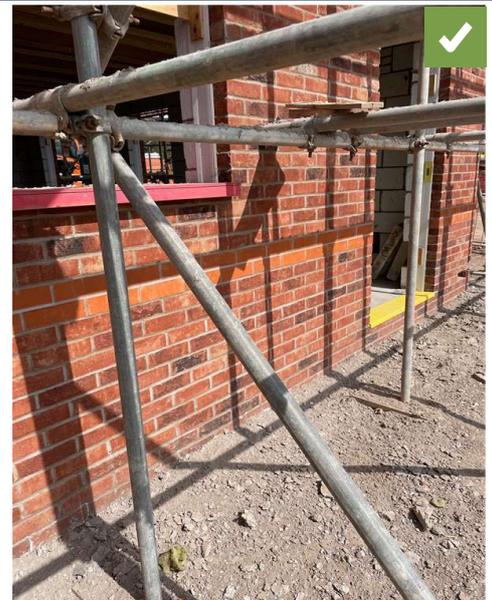
- Multiple plots were available with 9 viewed at this build stage, plots 364, 365, 366-367, 368-369, 370 & 481-482.
- Component/product/material details: Traditional cavity wall / External leaf (Clay brick) / Render / Movement joints.
- Contractor details: Malvern Brickwork (Bricklaying contractor).
- Quality was outstanding and consistent across the plots seen.

- Masonry was completed to a good line and level, without excessive deviation from the vertical plane.
- Bed and perpend joints were fully filled to the masonry structure.
- Bed and perpend joints were in line.
- Corbelling to the masonry did not exceed more than a third of the size of the unit.
- Masonry was uniform in colour, without excessive banding.
- Window and door openings were square without excessive tolerances.
- The cavity side of the brickwork had been neatly pointed.
- Meter boxes were protected during construction.

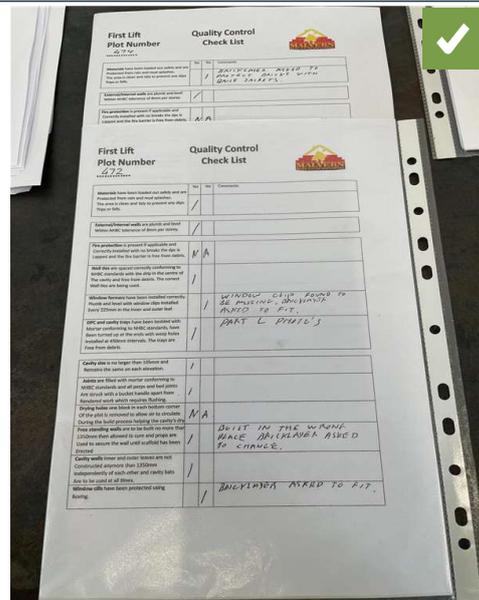
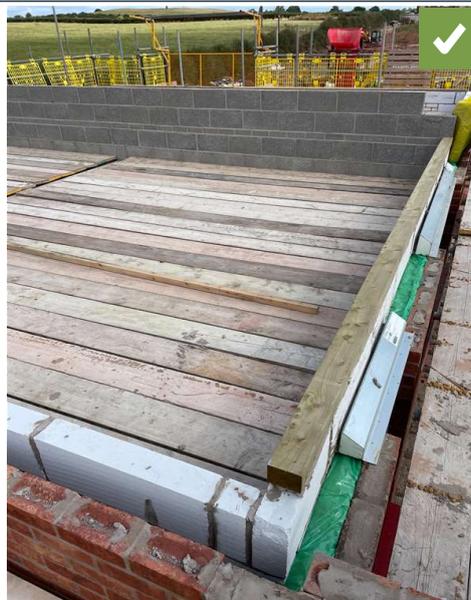
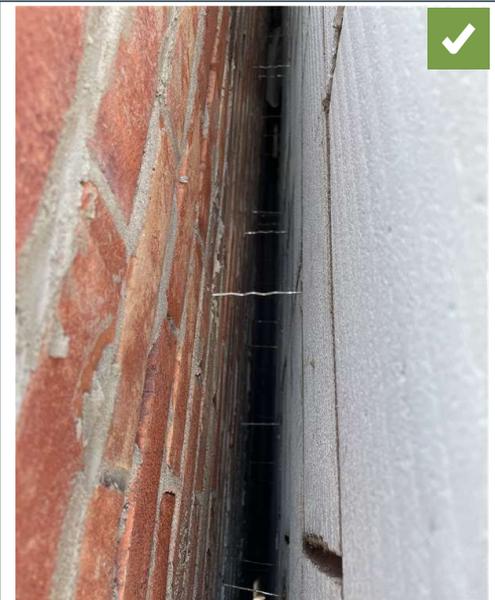
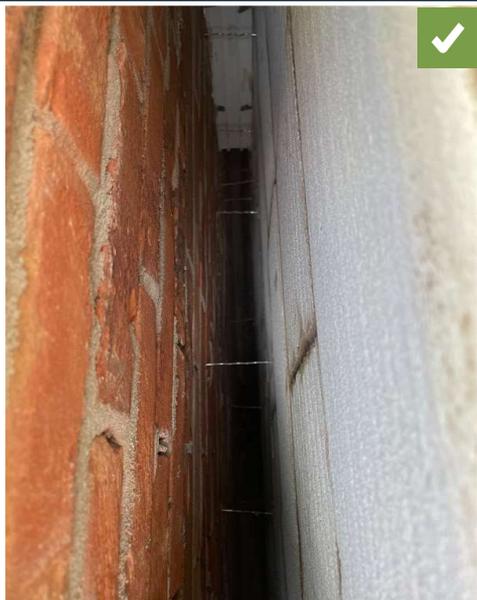
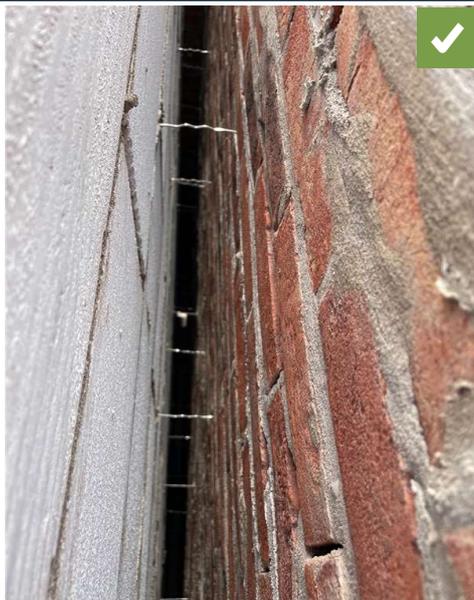
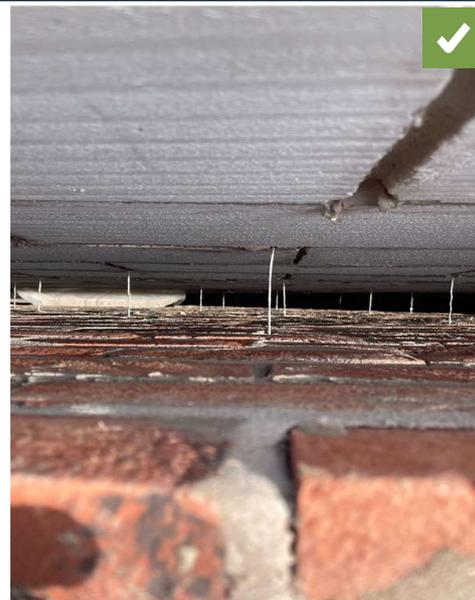
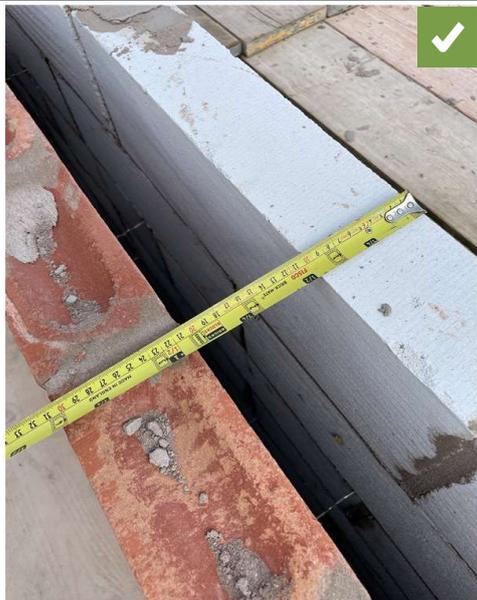
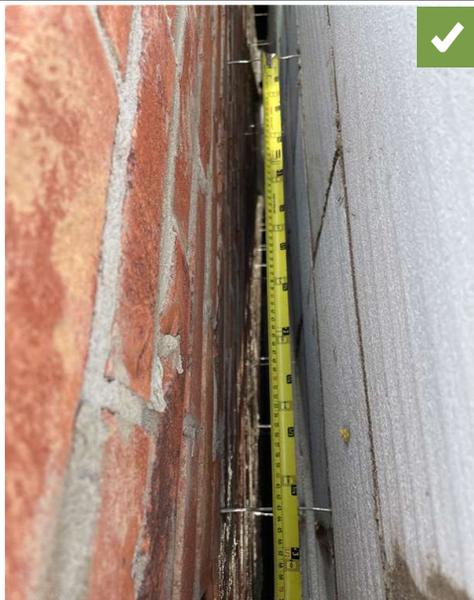
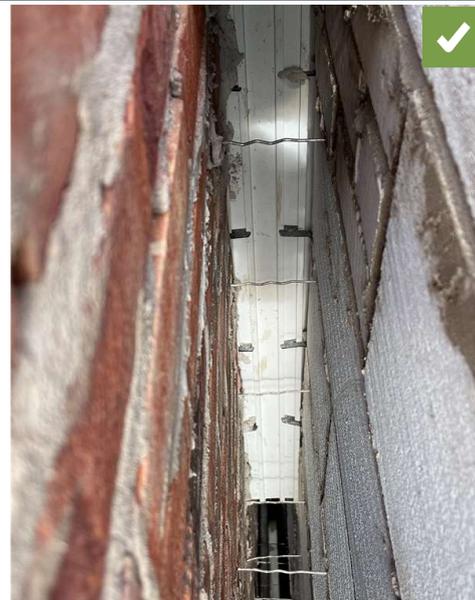
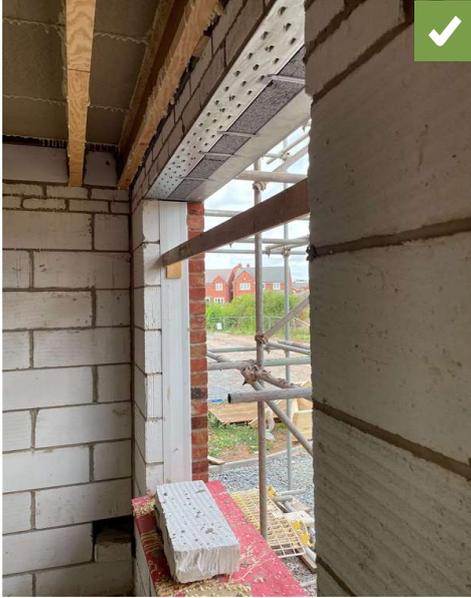
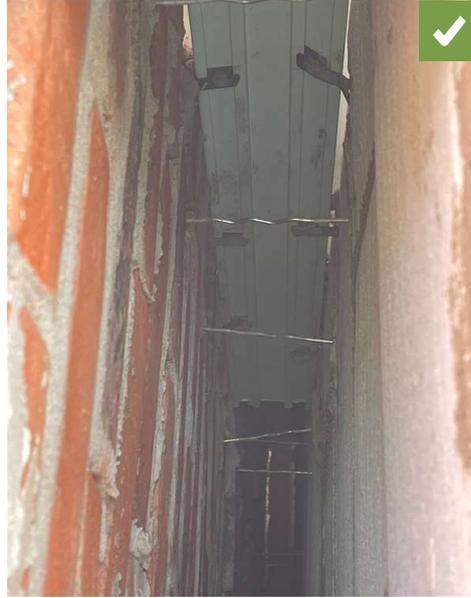
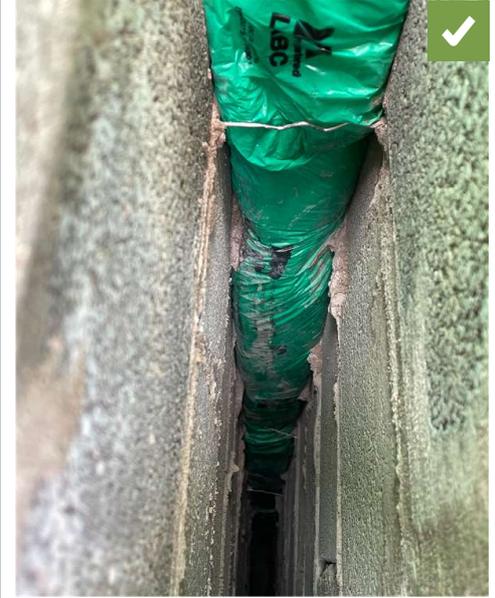
- Multiple plots were available with 2 viewed at this build stage, plots 481-482.
- Component/product/material details: Traditional cavity wall / Wall ties / Cavity Closers / Insulation (Blown).
- Contractor details: Malvern Brickwork (Bricklaying contractor).
- Quality was very good and consistent across the plots seen.

- Quality control documentation was completed and viewed.
- Cavities were clean and free from debris.
- Wall ties were neatly laid at 90 degrees to the face of the masonry.
- The cavities were built with uniform widths.
- General wall ties installed with a maximum spacing of 900mm horizontal and 450mm vertical centres.
- Window former ties were incorporated into the masonry at correct centres.
- Cavity closers were cut accurately and fitted tight into cavities.
- Wall ties were installed within 225mm horizontally and 300mm vertically of the opening.
- Separating wall ties were correctly installed as per Robust Details & Approved Document E with no more than 2.5 ties per m2.

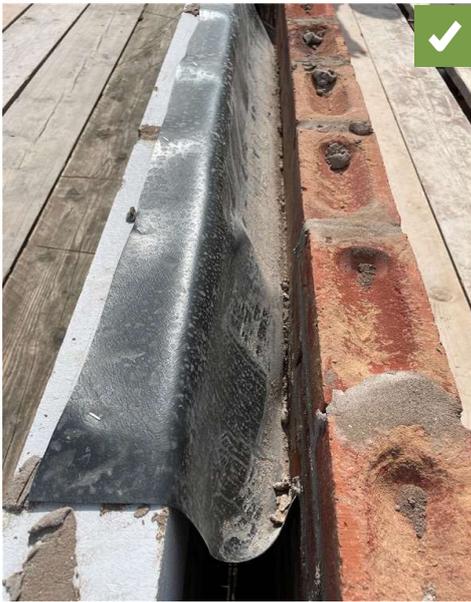
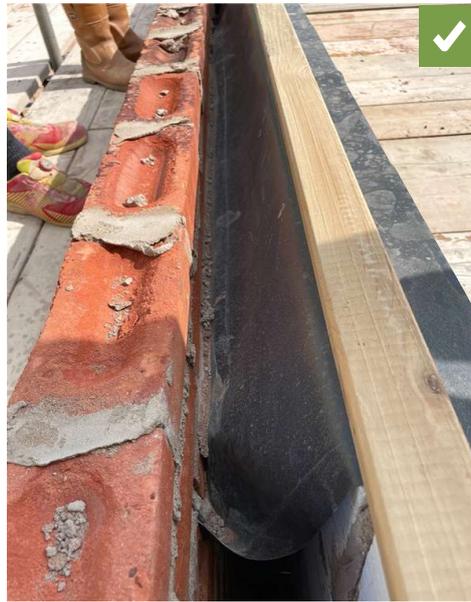
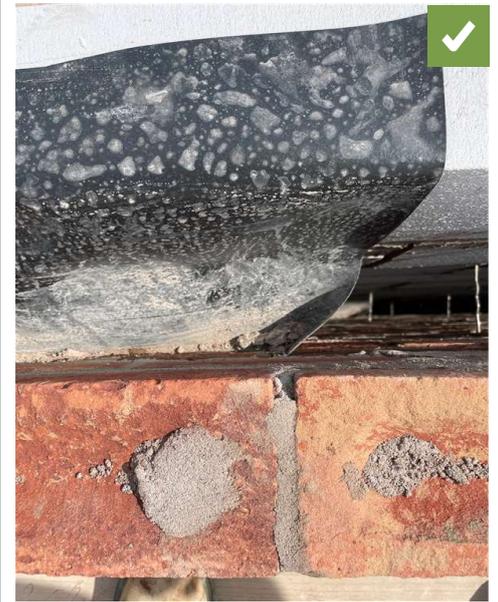
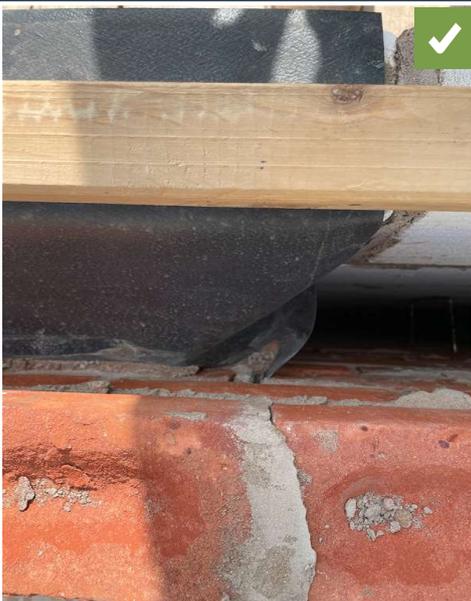
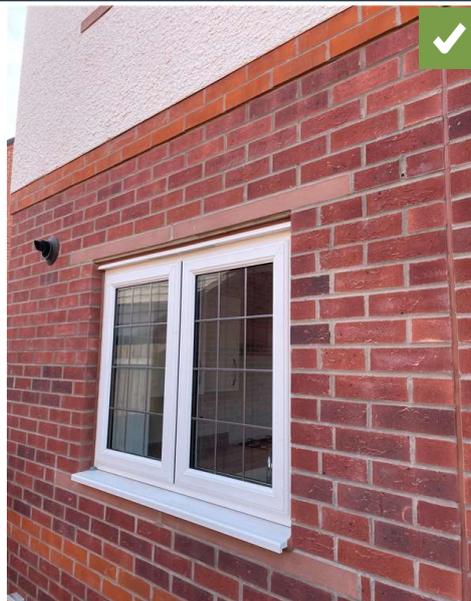
- Multiple plots were available with 3 viewed at this build stage, plots 370 & 481-482.
- Component/product/material details: Horizontal trays (flexible & preformed) / Weep holes.
- Contractor details: Malvern Brickwork (Bricklaying contractor).
- Quality was very good and consistent across the plots seen.

- Cavity trays were correctly positioned over all openings.
- Cavity trays were generally clean and free from debris.
- Both cavity tray ends correctly turned up a minimum of 75mm or in a full perpend joint.
