Site Assessment

Hereford Point

Roman Road, Hereford HR4 9QP

Reviewed - 21-08-2024

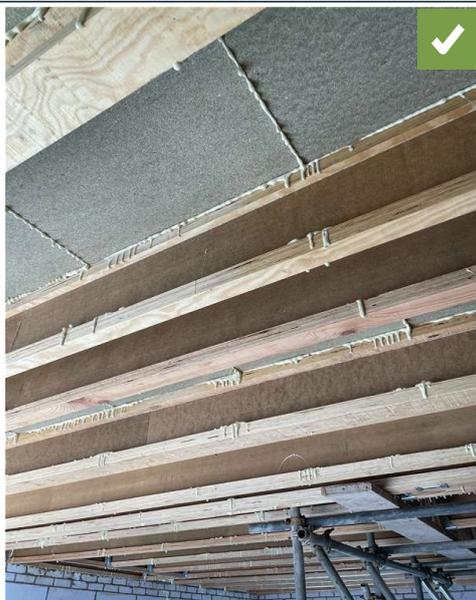
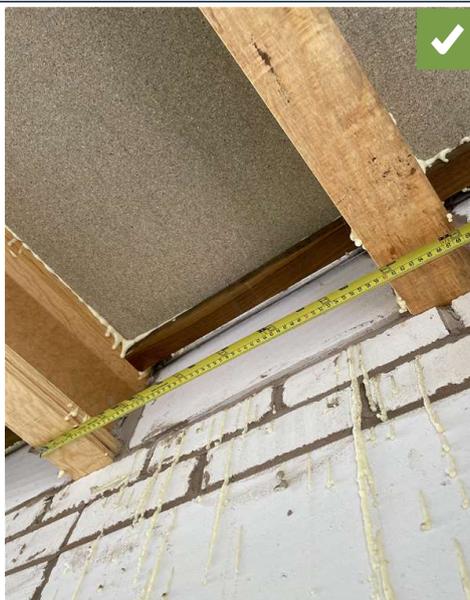
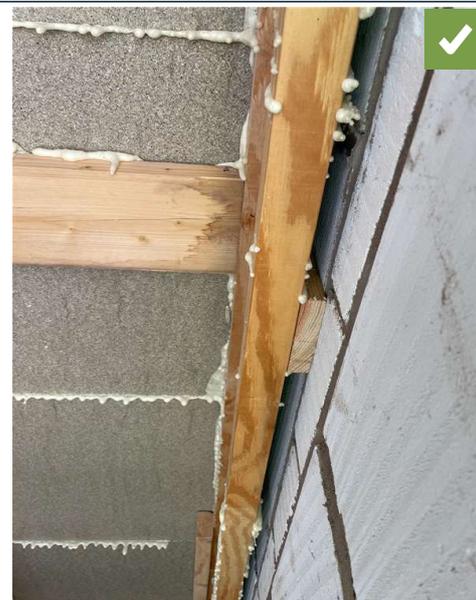
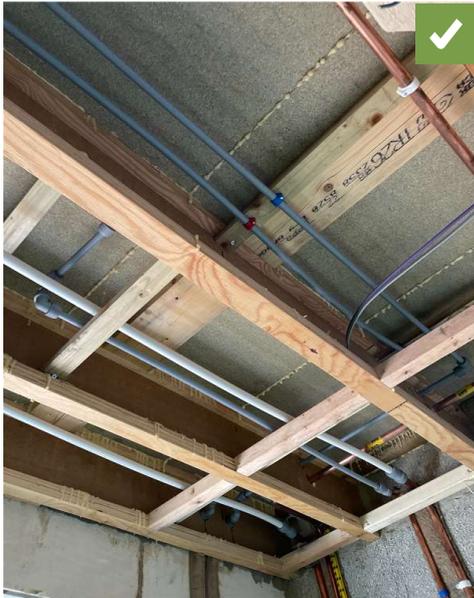
- Multiple plots were available with 3 viewed at this build stage, plots 481-482 & 545.
- Component/product/material details: Engineered I-Joists (Mon joists)
- Contractor details: Mike Lewis Carpentry (Carpentry contractor).
- Quality was outstanding and consistent across the plots seen.

- Joists were installed parallel and did not exceed 600mm centres.
- Adequate packing provided between the wall and the first joist directly under the restraint strap.
- Solid timber noggings, at least 0.5 times the joist depth, were installed directly under the restraint straps per the design.
- Support noggings were fitted to the underside of partition walls in accordance with the design.
- Joist hangers were fitted tightly around joists and fully nailed.
- Joists were seated correctly in hanger
- Perimeter noggings were installed in accordance with the design.
- Additional noggings were provided for plasterboard support to ceiling perimeters and ends of boards.

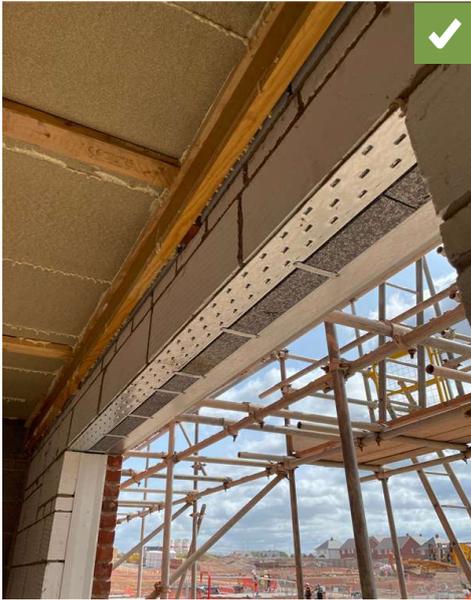
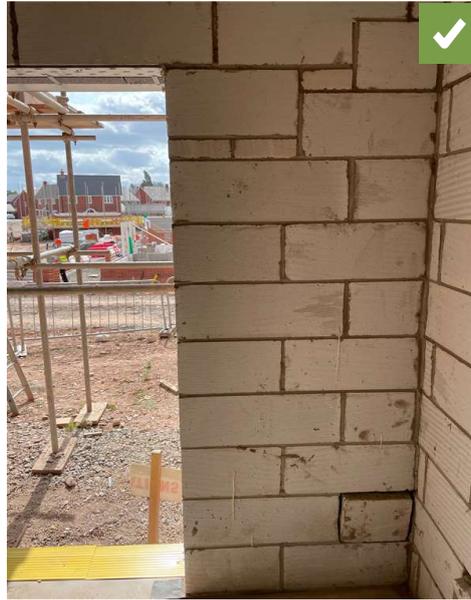
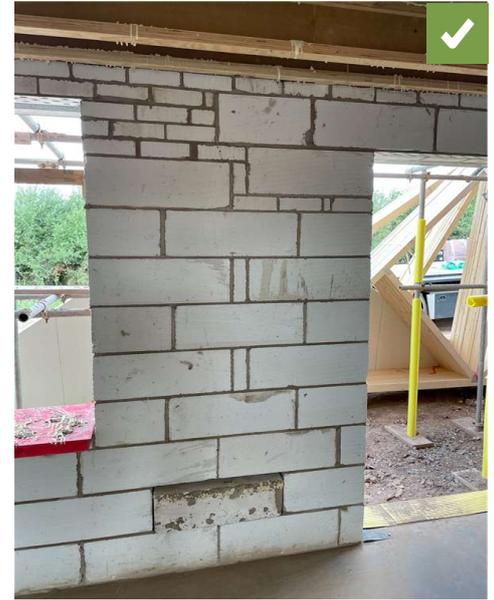
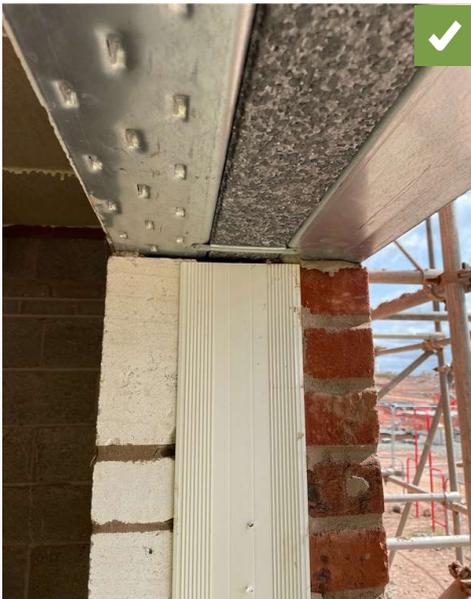
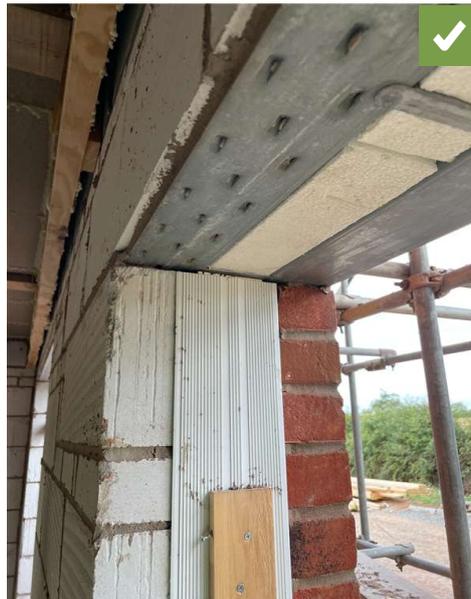
- Multiple plots were available with 2 viewed at this build stage, plots 481-482.
- Component/product/material details: Steel simple & combined lintels.
- Contractor details: Malvern Brickwork (Bricklaying contractor).
- Quality was very good and consistent across the plots seen.

- Galvanised lintels were used where embedded or partially embedded in the building envelope.
- All lintels were bearing onto an adequately sized block
- Lintels were set on a full mortar bed.
- Combined lintels (with a cavity tray) had a minimum bearing of 150mm.

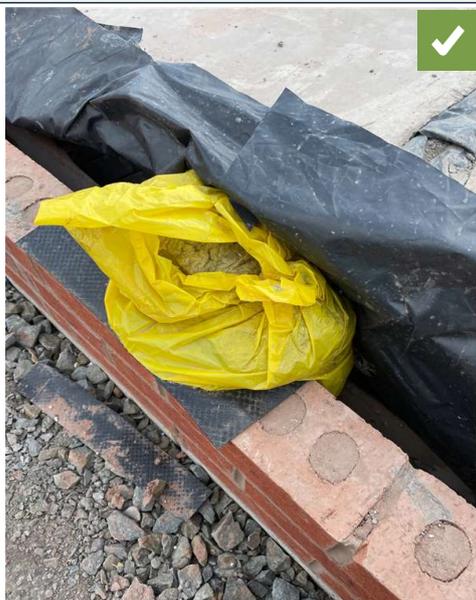
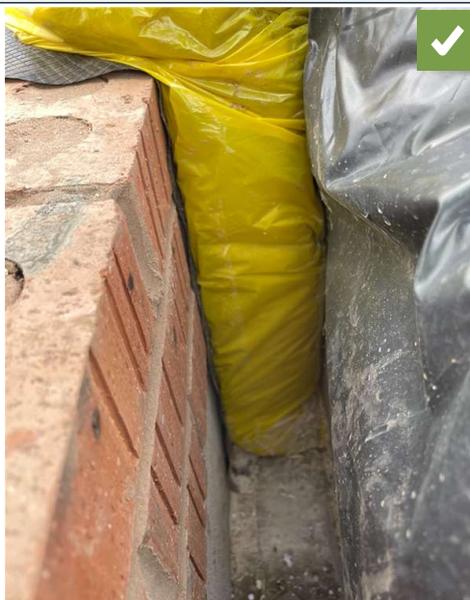
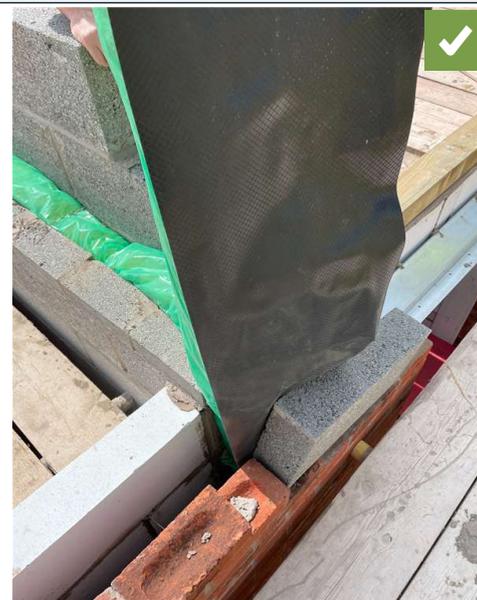
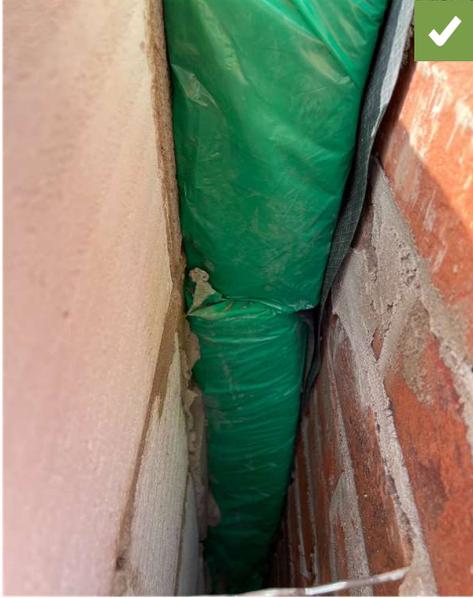
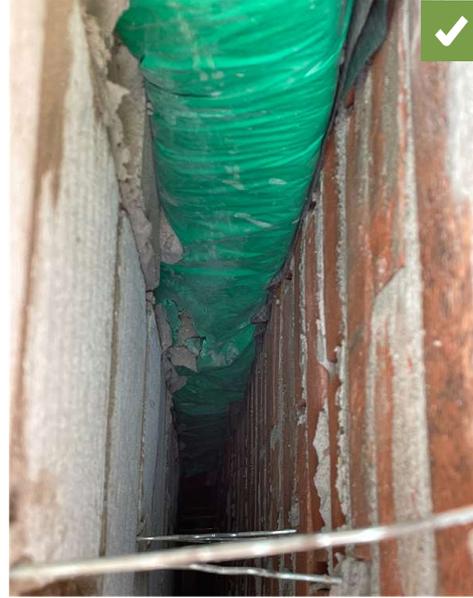
- Multiple plots were available with 4 viewed at this build stage, plots 481-482 & 489-490.
- Component/product/material details: Bagged fibre cavity barriers (ARC).
- Contractor details: Malvern Brickwork (Bricklaying contractor).
- Quality was very good and consistent across the plots seen.

- The separating wall cavity barrier extended to the base of the cavity.
- DPM provided between cavity barrier and external masonry.
- Vertical cavity barriers were installed where required as work proceeds.
- A tight friction fit was observed for all cavity barriers between the two masonry leaves.
- The butt jointing of barriers was precise and gap-free.

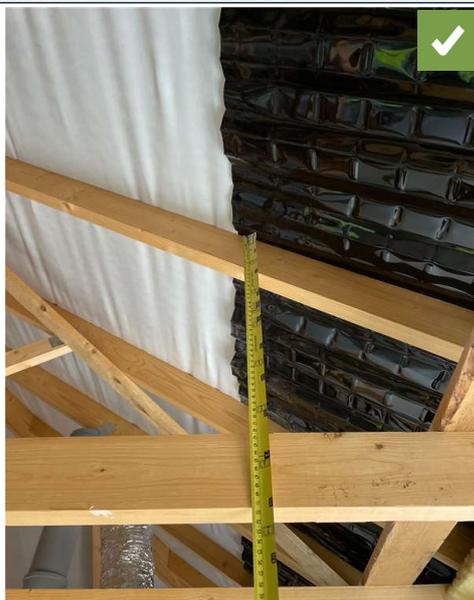
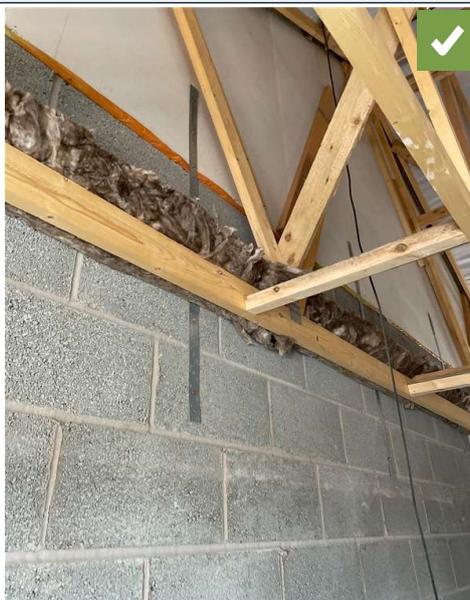
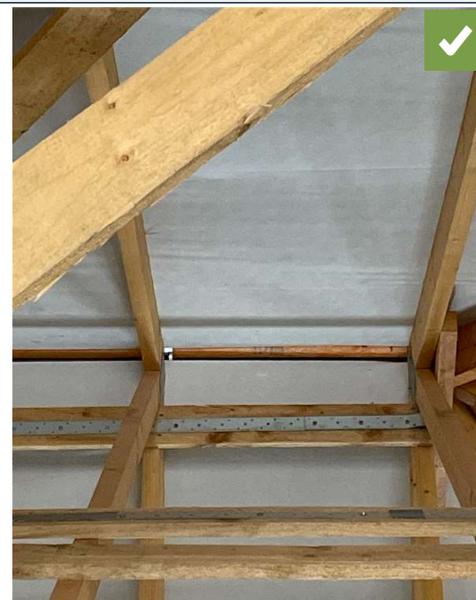
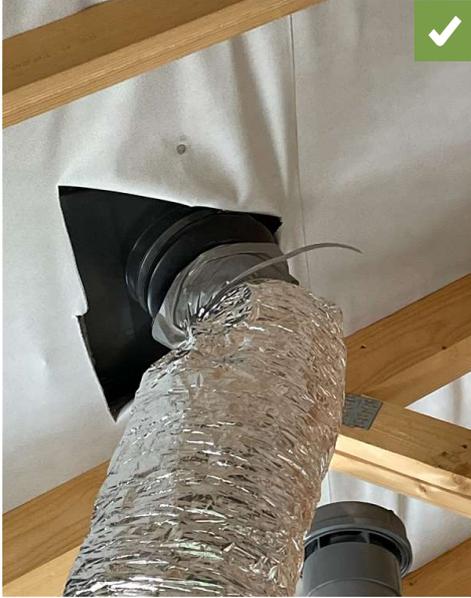
- 1 plot was available and viewed at this build stage, plot 545.
- Component/product/material details: Breathable Roofing felt / Ventilation / Insulation.
- Contractor details: Browns Roofing (Roofing contractor).
- Quality was very good and consistent across the plot seen.

- Adequate ventilation to the roof space was achieved by correctly positioning rafter ventilators, high enough to avoid blockage by loft insulation.
- Insulation provided between wall and adjacent truss.
- Adequate ventilation was provided at ridge.
- Penetrations through the under felt had been neatly cut.

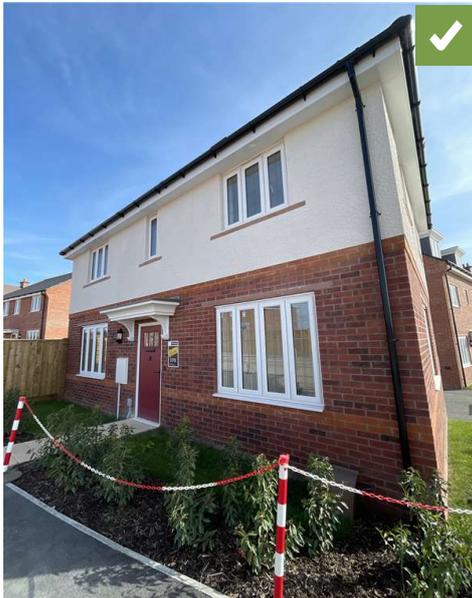
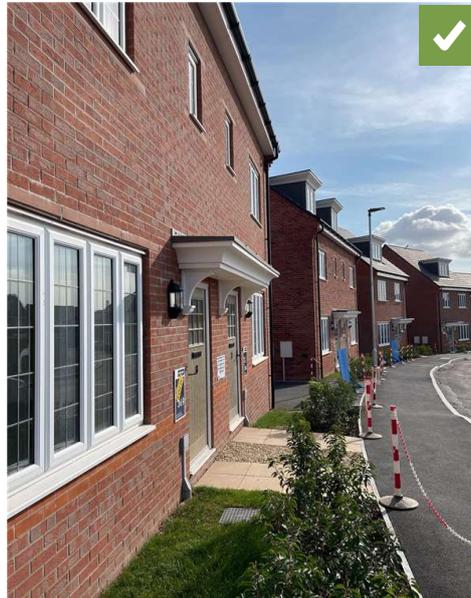
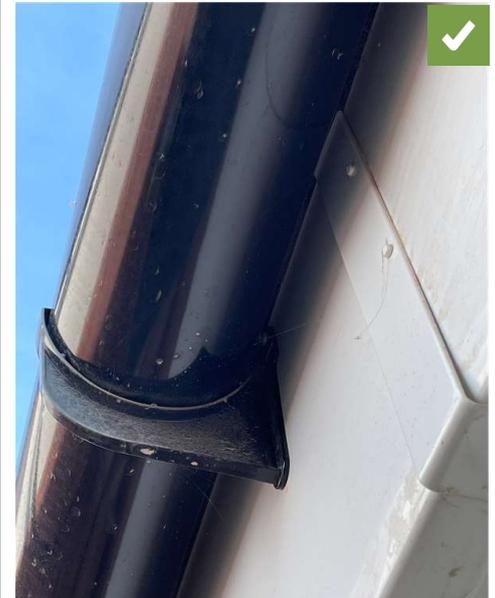
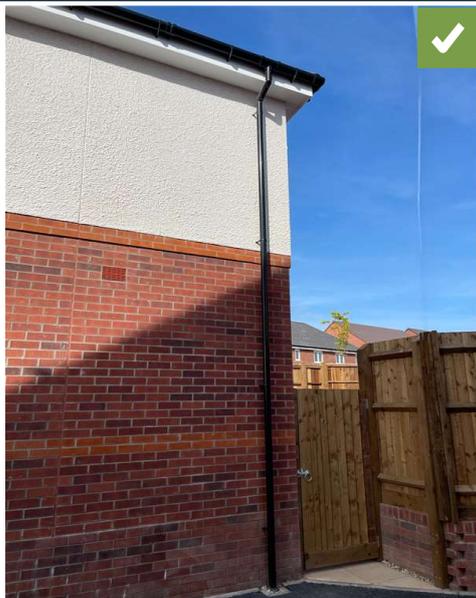
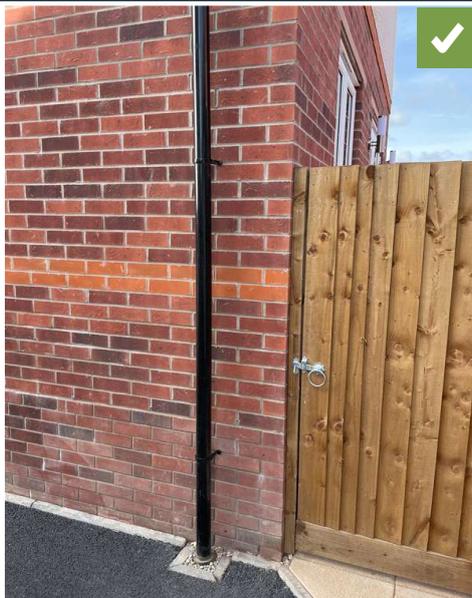
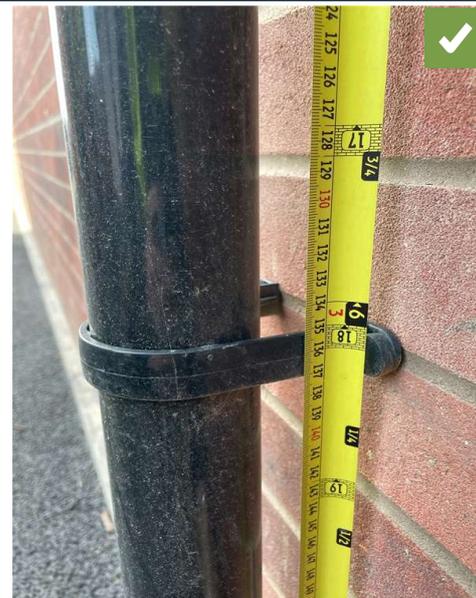
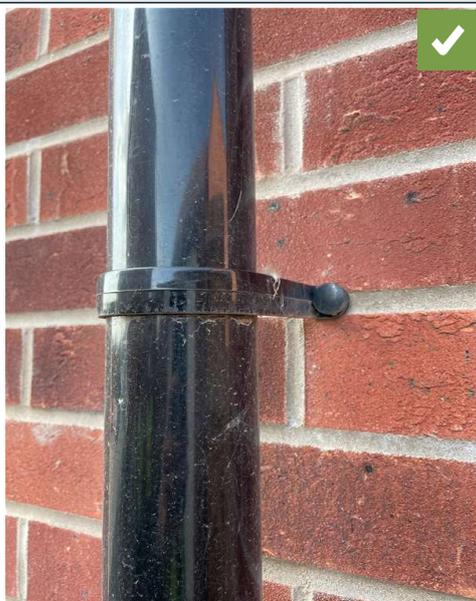
- Multiple plots were available with 7 viewed at this build stage, plots 364, 365, 366-367, 368-369 & 370
- Component/product/material details: PVC gutters and downpipes (Polypipe).
- Contractor details: Hamilton Thurston (Plumbing contractor).
- Quality was very good and consistent across the plots seen.

- Good support to gutters with evenly spaced brackets at correct centres.
- Correct screws used for gutter brackets.
- Downpipe brackets were installed not exceeding manufacturer's recommended vertical centres.
- Downpipes were installed consistently plumb.
- Dome head screws provided to all downpipe brackets.

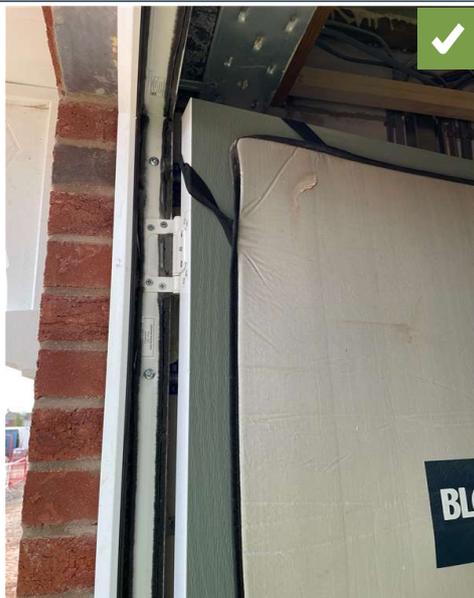
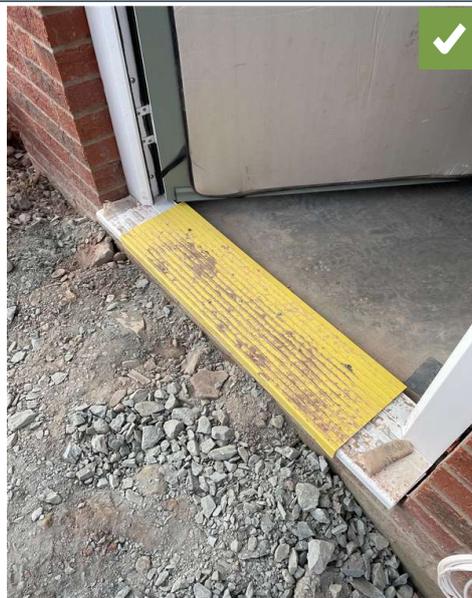
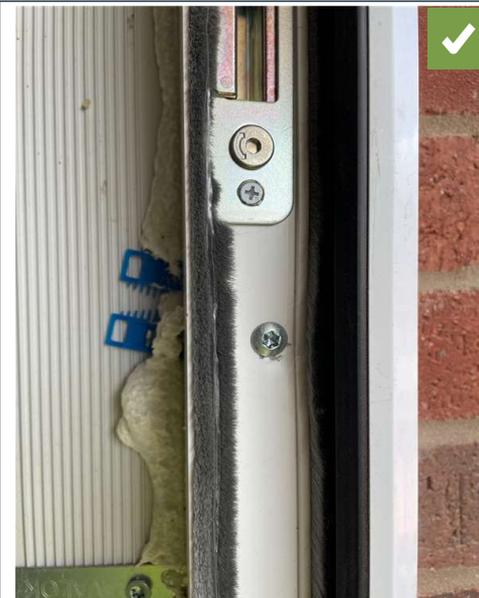
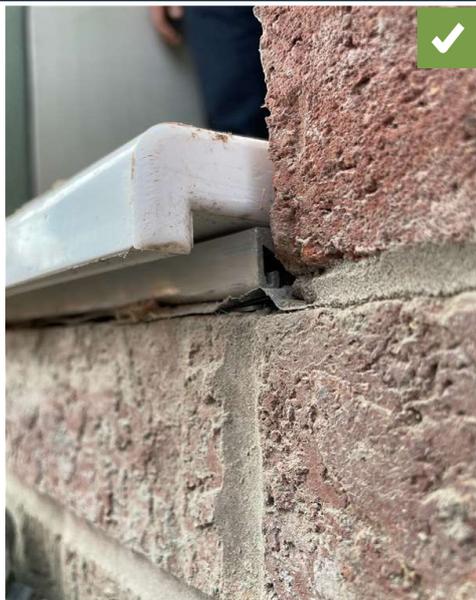
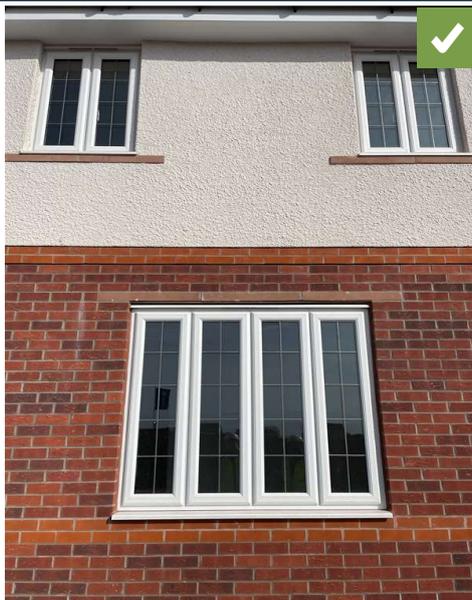
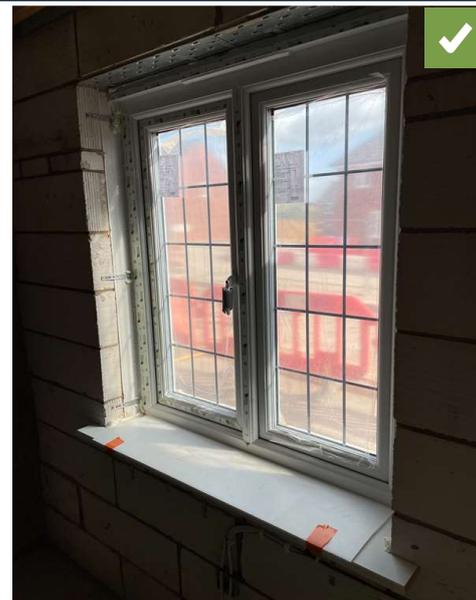
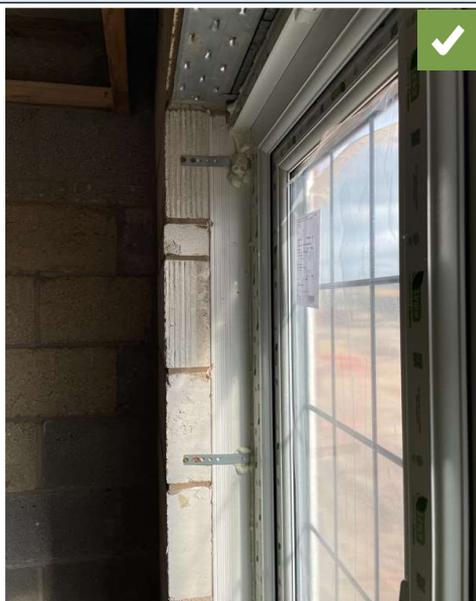
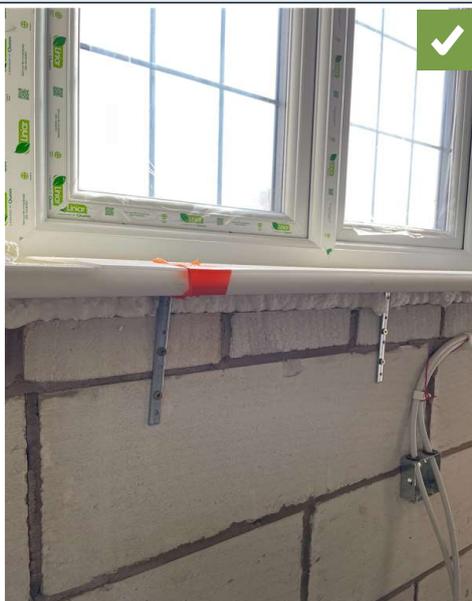
- Multiple plots were available with 2 viewed at this build stage, plots 370 & 545.
- Component/product/material details: uPVC windows (A&B Glass Group) / External composite doors (Vista Doors).
- Contractor details: A&B Glass Group (Supply & fit) / Lewis Carpentry Contractors (Entrance door installer).
- Quality was outstanding and consistent across the plots seen.

- Protection had been provided to the door leaves.
- Door thresholds were adequately protected.
- Door frames were precisely installed to ensure thermal continuity with the external walls.
- Proprietary washer head door fixings were used as per the specification.
- The door cills were reinforced using a proprietary steel support.
- Windows and doors were accurately positioned in their openings.
- Brackets to windows were fitted at max 600mm centres and 150mm from top and bottom of the frame.
- Brackets were aligned according to the manufacturer's specifications.
- Windows boards were securely fixed.

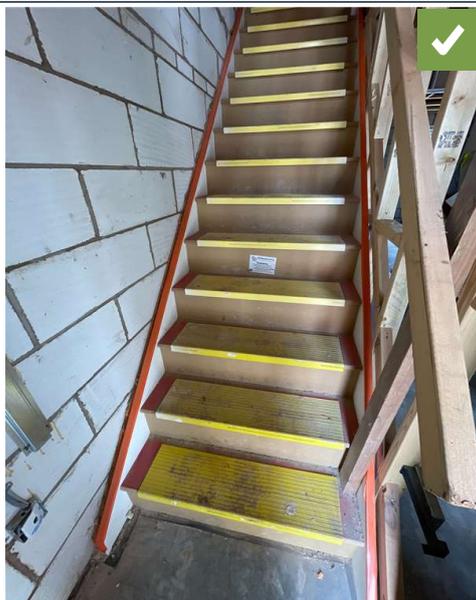
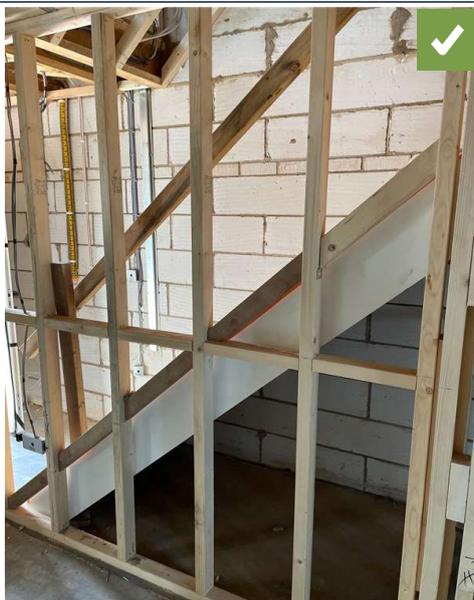
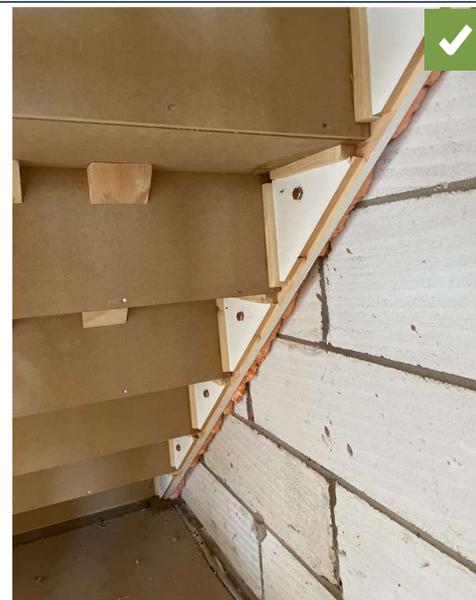
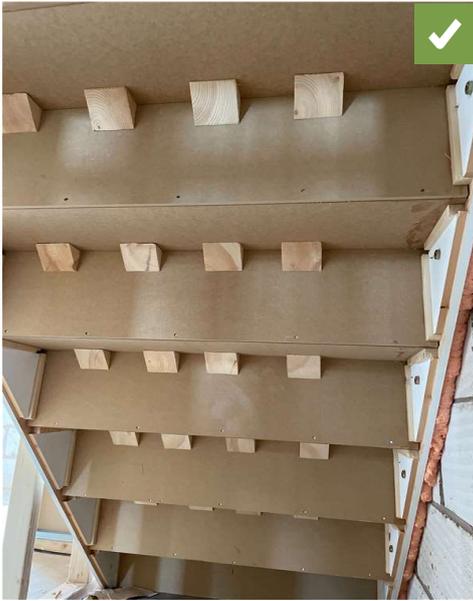
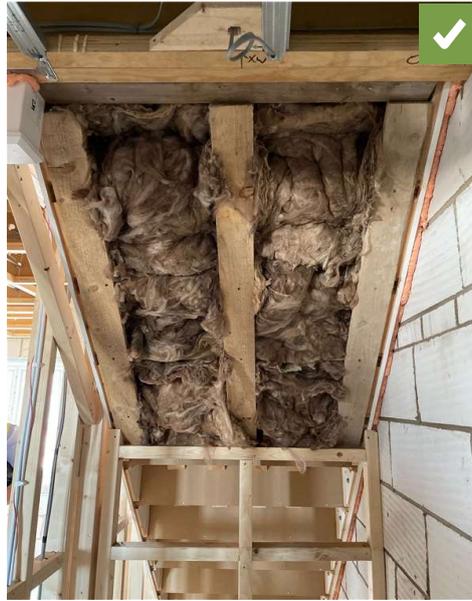
- Multiple plots were available with 2 viewed at this build stage, plots 482 & 545.
- Component/product/material details: Floor decking (CaberDek) / Timber stairs (GD Woodwork).
- Contractor details: Lewis Carpentry Contractors (Carpentry contractor).
- Quality was outstanding and consistent across the plots seen.

- Stair treads were adequately protected.
- Stair fixings installed through full length packer in line with BWF guidance.
- Staircases were installed in accordance with manufacturer's guidance / British Woodworking Federation.
- All stair treads and risers had been securely fixed with packers and wedges.
- Insulation installed below stairs to reduce sound transmission.
- Soil and waste pipes were insulated for sound.
- The adhesive completely filled the joints, and it was visible between the boards underneath the decking.

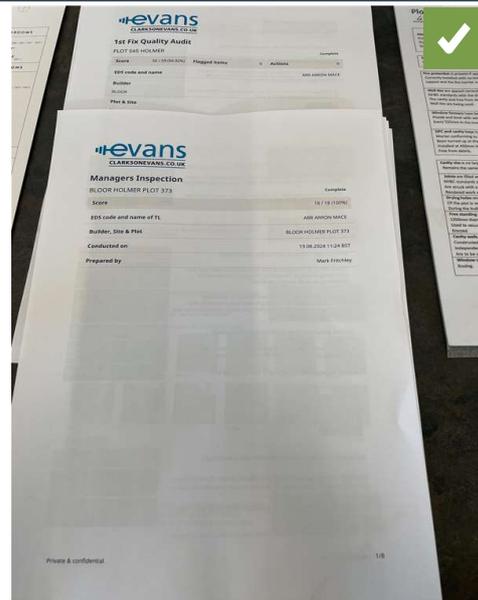
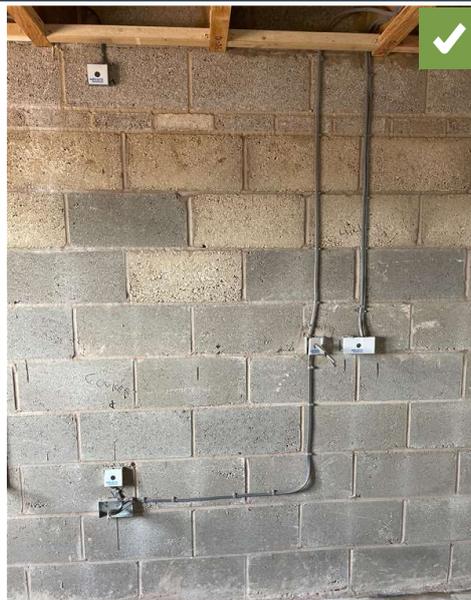
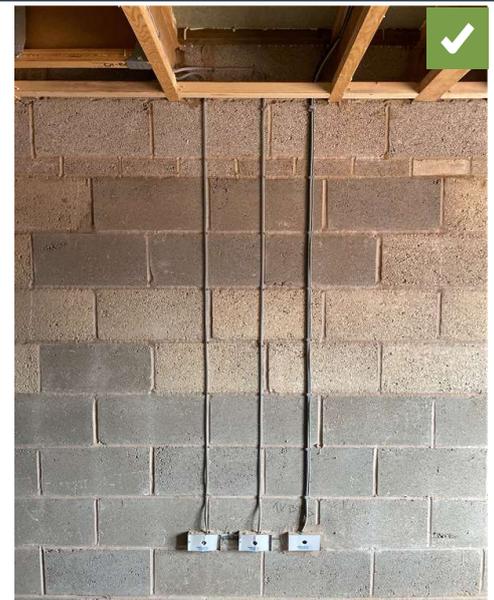
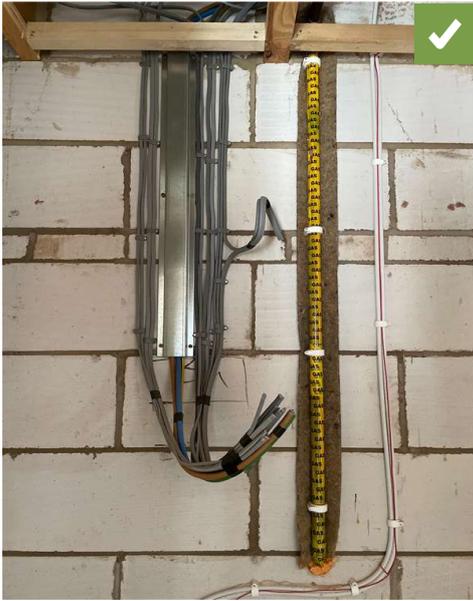
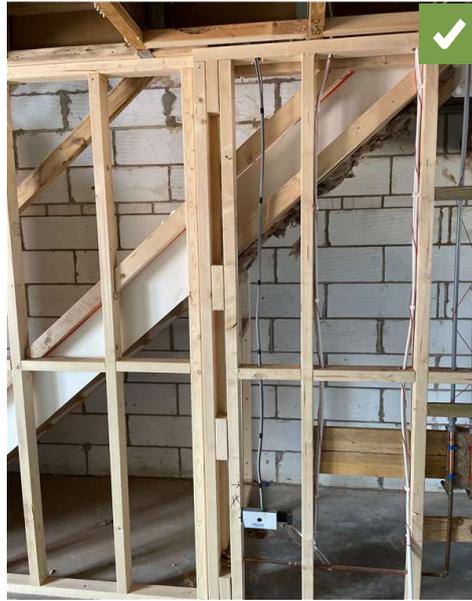
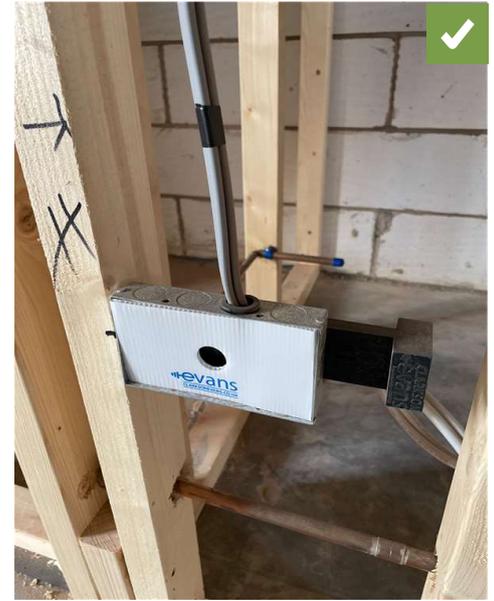
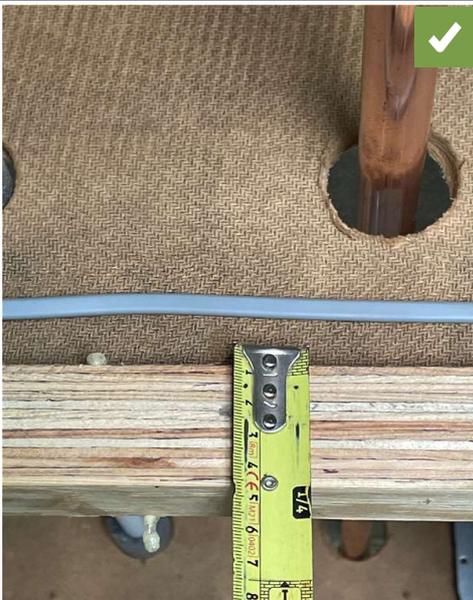
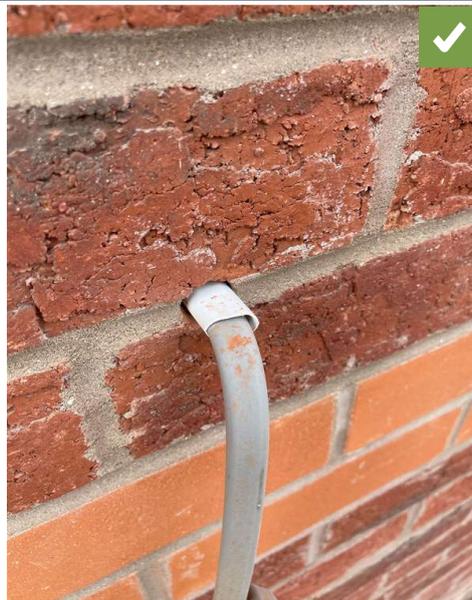
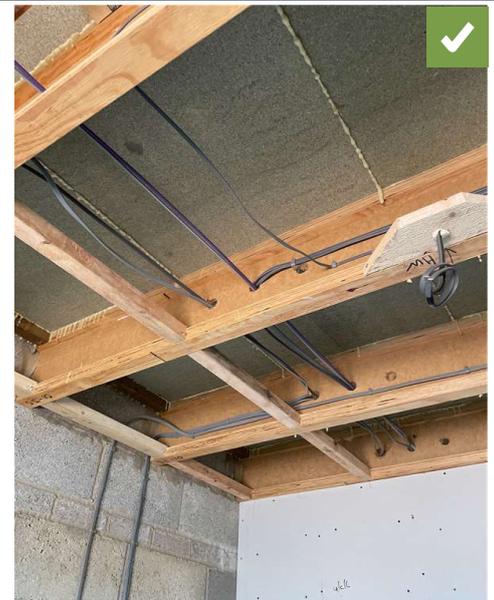
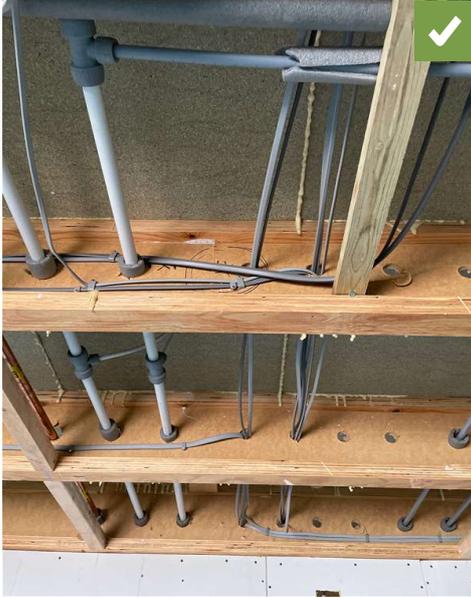
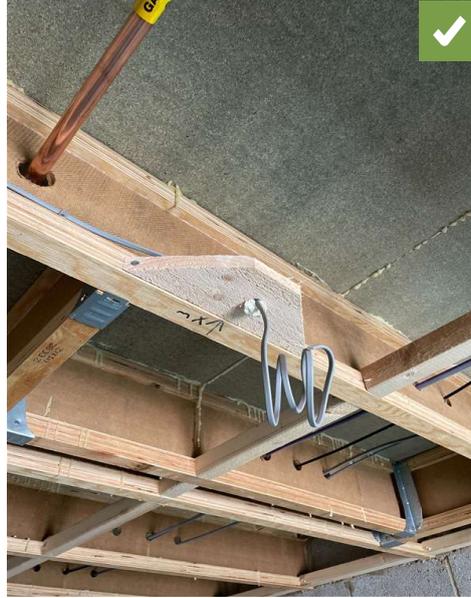
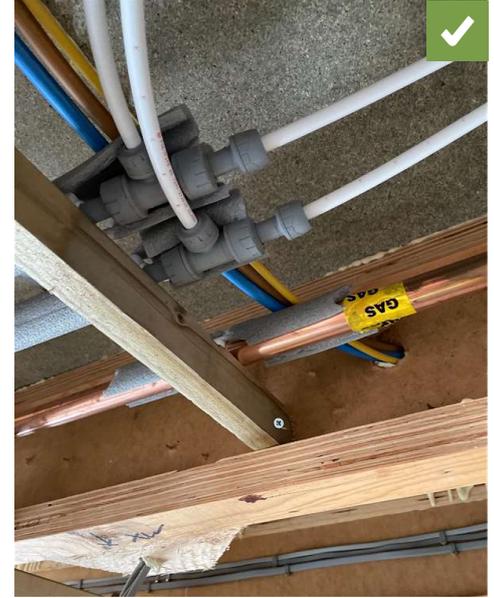
- 1 plot was available and viewed at this build stage, plot 545.
- Component/product/material details: Electrical supply & distribution / Cables / Back Boxes / Protection.
- Contractor details: Clarkson Evans (Electrical contractor).
- Quality was very good and consistent across the plot seen.

- Quality control documentation was completed and viewed.
- All cables were kept within safe zones in line with BS7671.
- All cables were neatly clipped with adequate support at the recommended centres.
- Protection was provided to incoming supply to consumer unit.
- Cable drops in studwork were pulled taut.
- Back boxes were protected with inserts.
- Good support provided with proprietary brackets.
- Cables achieved 50mm cover from the top or bottom of the joists.
- Cables passing through masonry leaves were protected by a sleeve.
- Cables were neatly clipped to the joists.
- Noggins / pattresses were provided for ceiling mounted items.
- Distribution cables were installed at least 25mm from gas pipework or separated by a non-conductive barrier as set out in BS 6891(1).

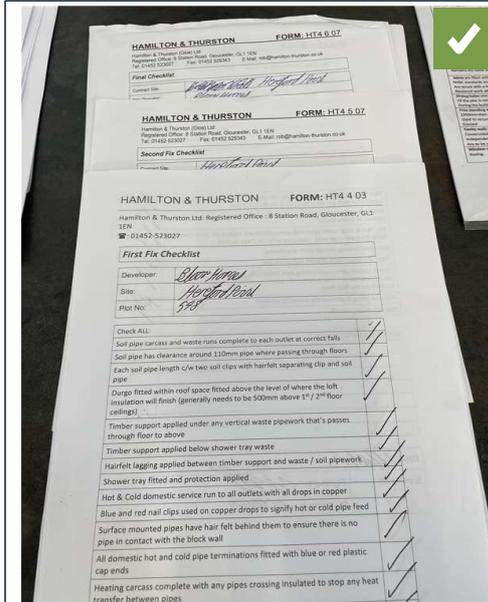
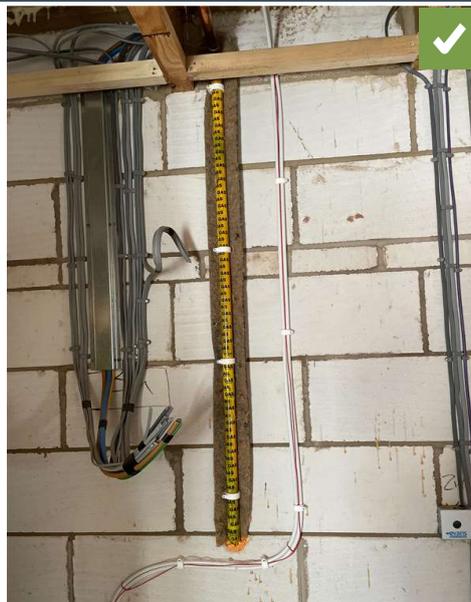
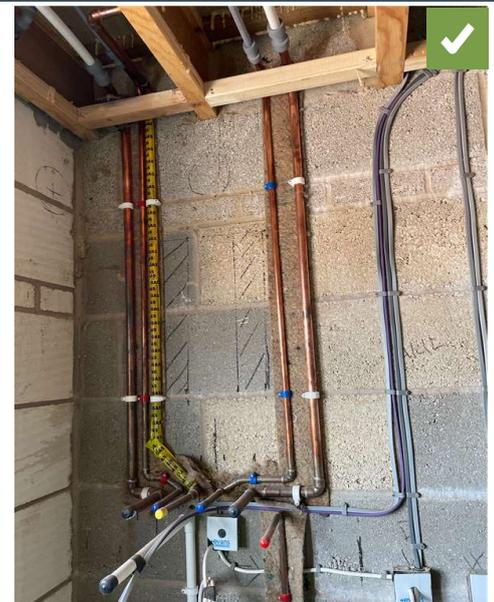
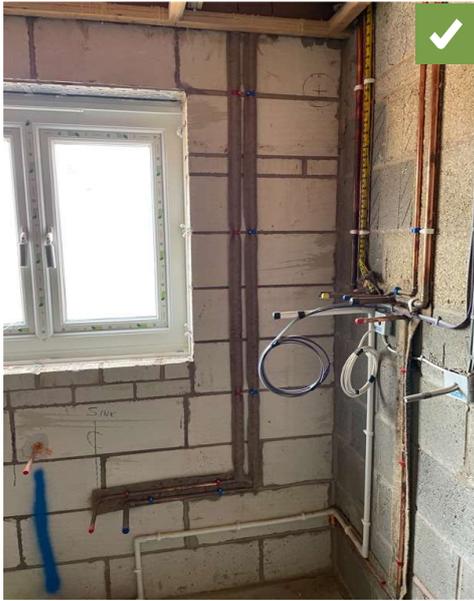
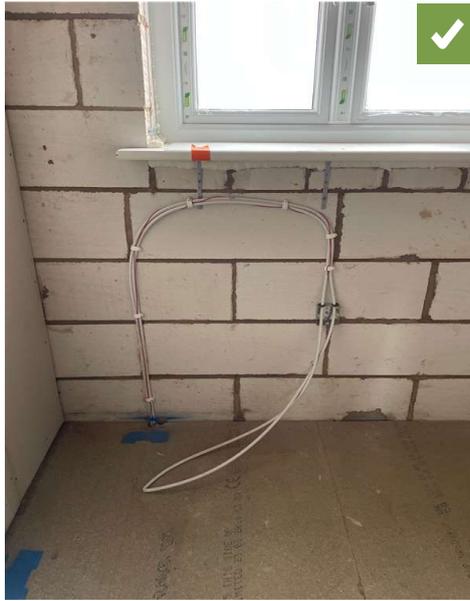
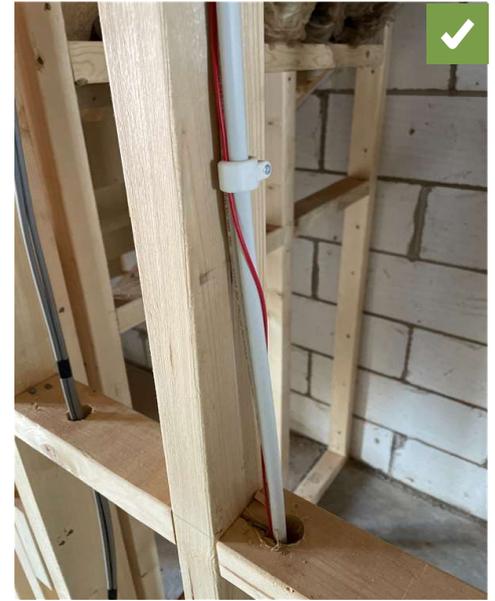
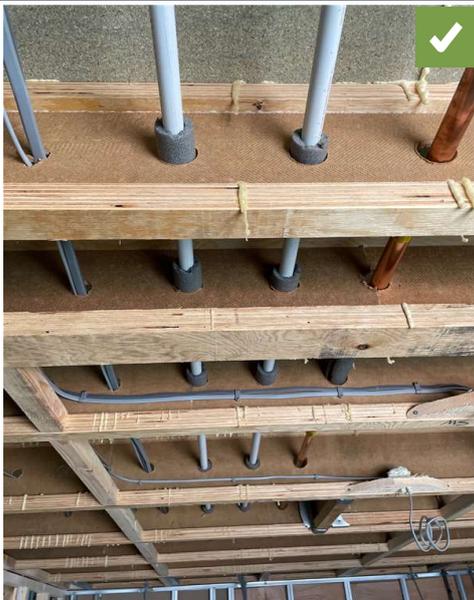
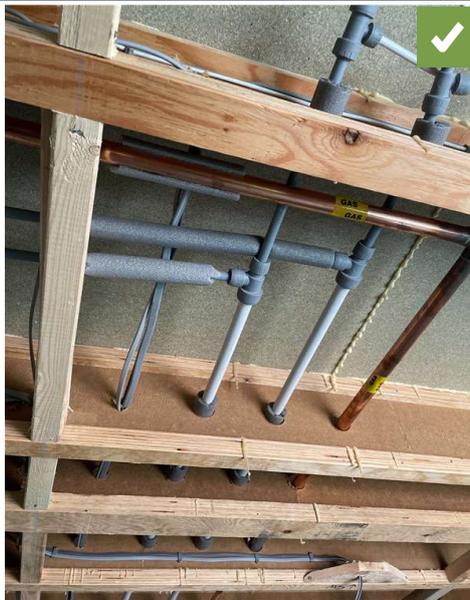
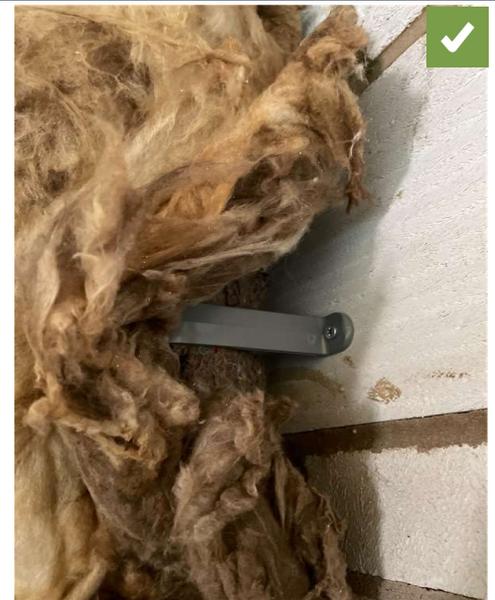
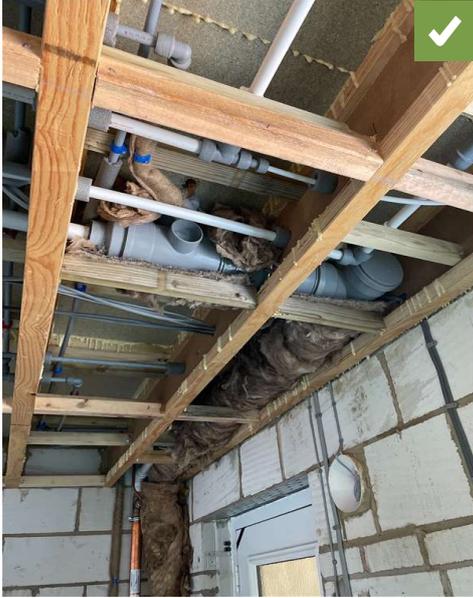
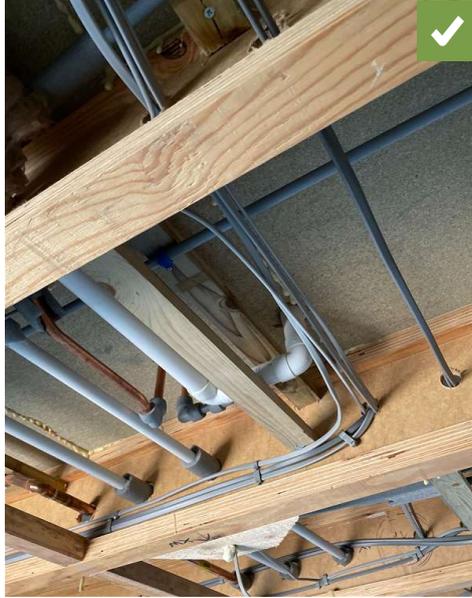
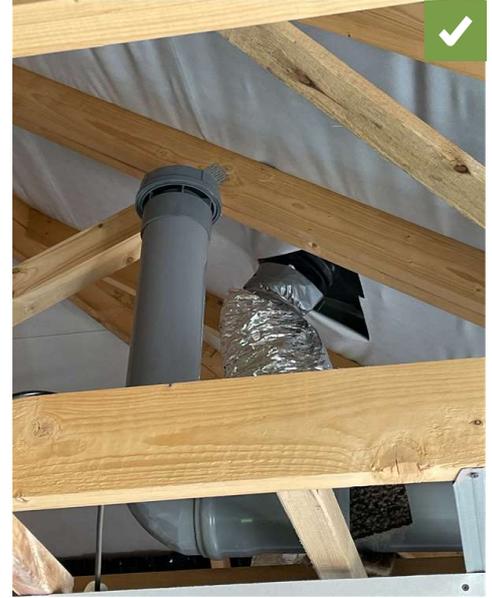
- 1 plot was available and viewed at this build stage, plot 545.
- Component/product/material details: Hot & cold-water supply & distribution / Gas supply / Protection.
- Contractor details: Hamilton & Thurston (Plumbing contractor).
- Quality was very good and consistent across the plot seen.

- Gas pipework was visibly identified.
- Hot and cold pipes were identified.
- Protection was provided to copper pipes installed on masonry walls.
- Tracer wire was provided to plastic pipework.
- Pipework was sleeved where passing through the joists.
- Pipework was well set out in straight runs.
- Pipework was neatly clipped, with support not exceeding 600mm centres.
- Soil vent pipe had the correct vertical fixing centres as per manufacturer's requirements.
- Waste pipes were installed in accordance with manufacturer's instructions.
- Air admittance valve was appropriately ventilating the soil vent pipe.

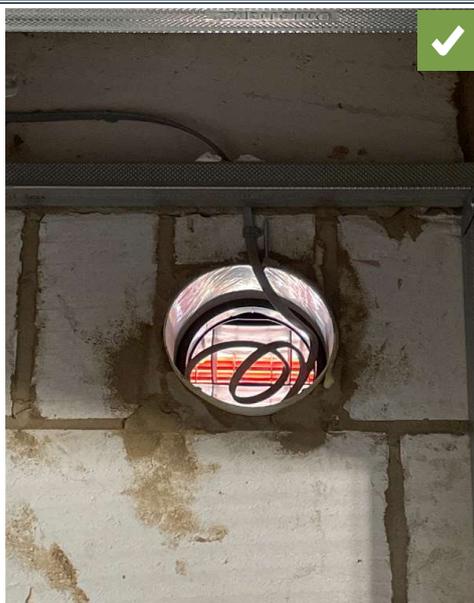
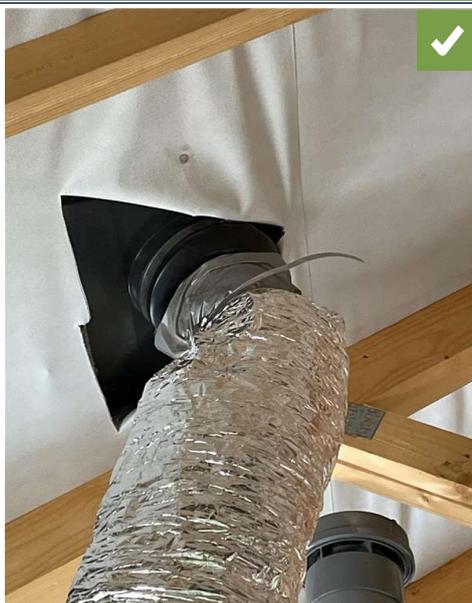
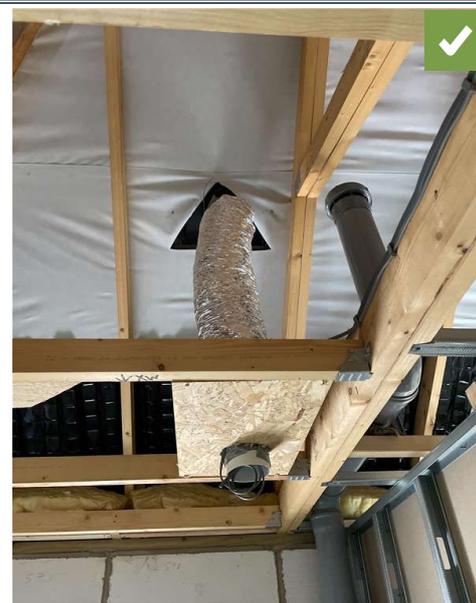
- 1 plot was available and viewed at this build stage, plot 545.
- Component/product/material details: Rigid ducting.
- Contractor details: Clarkson Evans (Electrical contractor).
- Quality was very good and consistent across the plot seen.

- Ducting penetrations at external walls were slightly sloped towards the outside.
- Insulated ducting was installed in unheated areas.
- Ducting was securely connected to the vent with a jubilee clip.
- Pattresses were provided for fixing of ceiling mounted fans.
