Site Assessment

Hereford Point

Roman Road, Hereford HR4 9QP

Reviewed - 21-08-2024

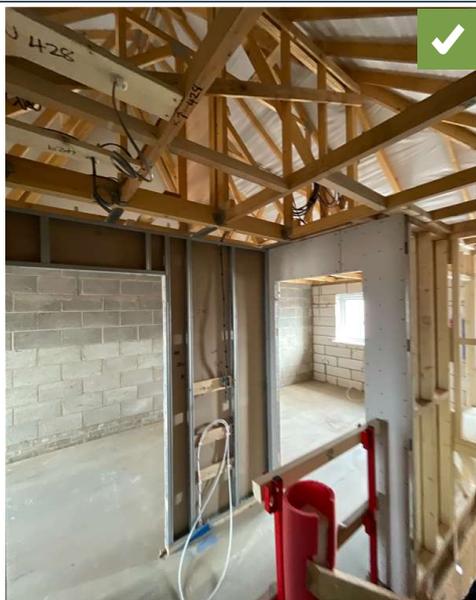
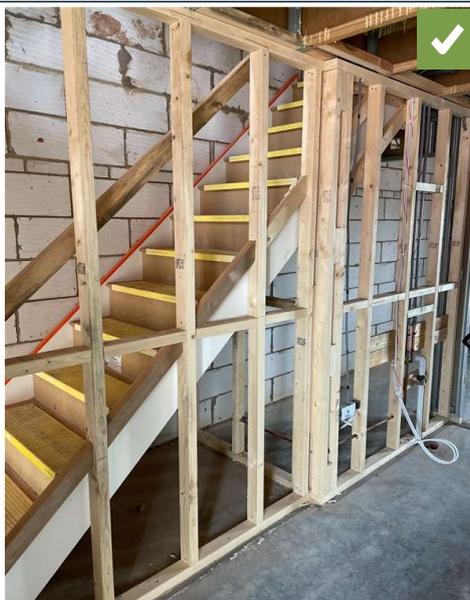
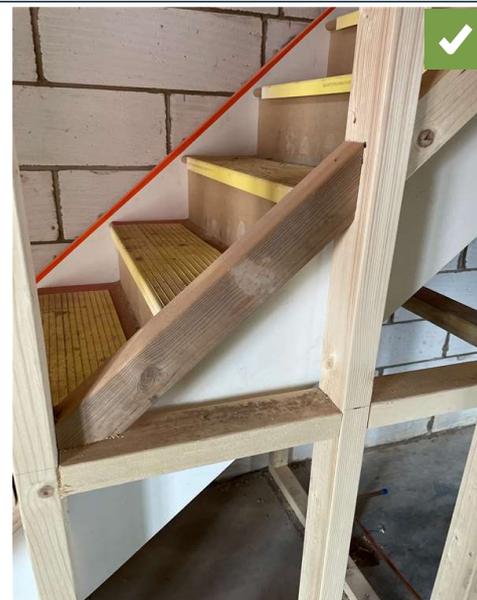
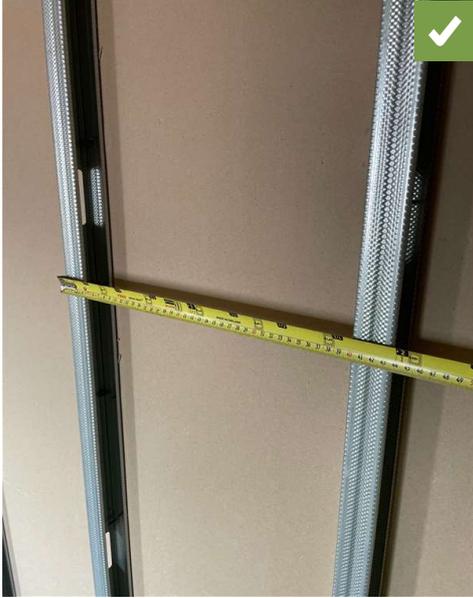
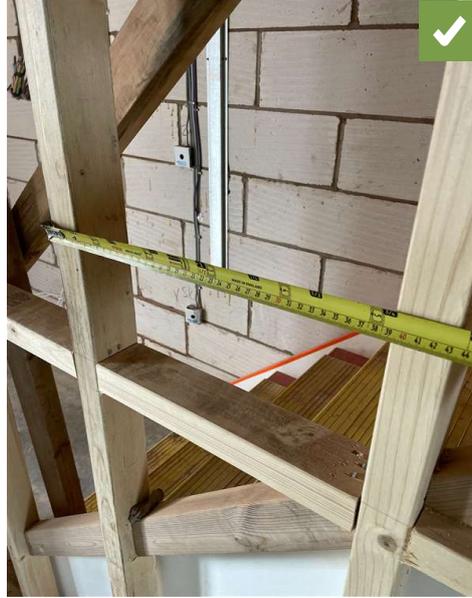
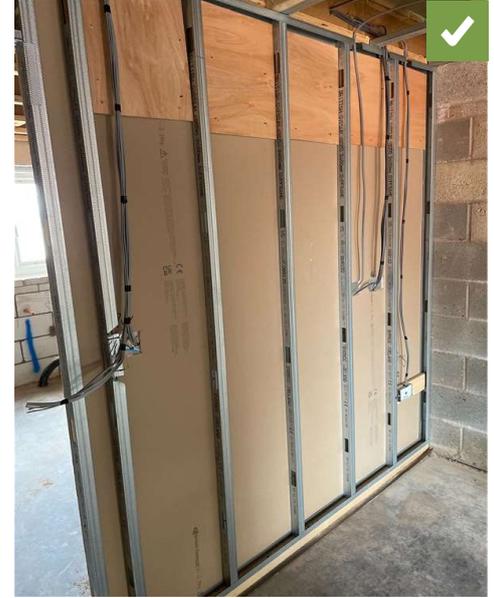
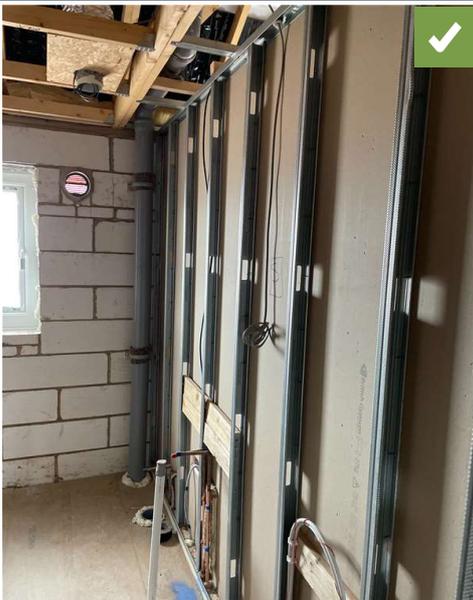
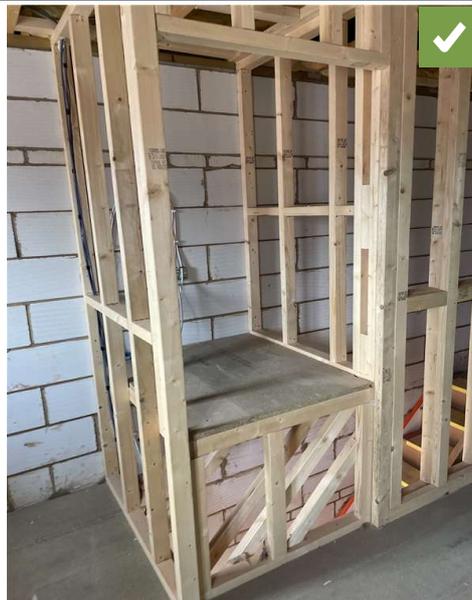
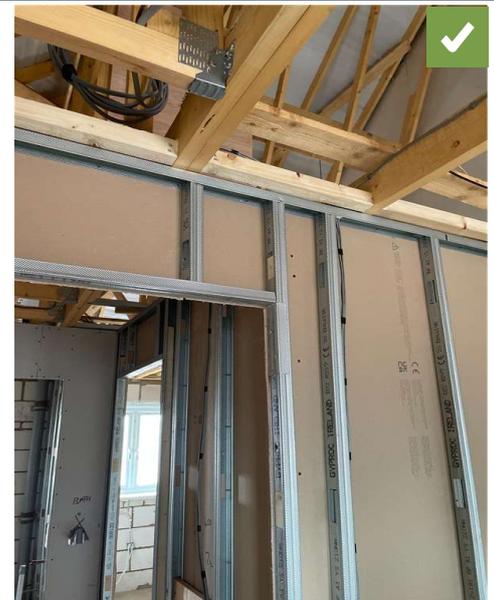
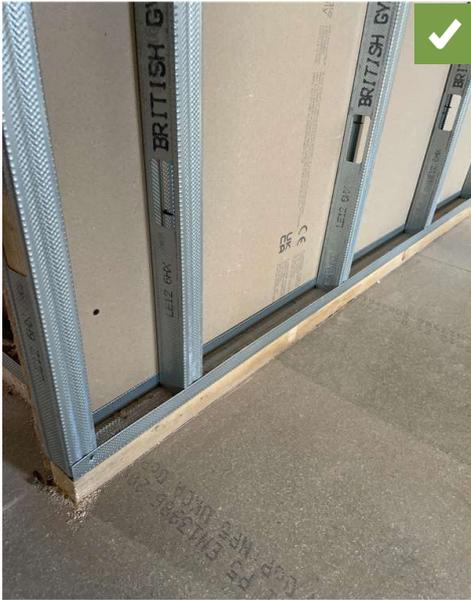
- 1 plot was available and viewed at this build stage, plot 545.
- Component/product/material details: Metal Stud Partition (BG - Gypframe).
- Contractor details: Johnson Drywall Ltd (Drylining contractor).
- Quality was very good and consistent across the plot seen.

- Studwork was constructed plumb and square.
- Additional noggings installed above stair string.
- The studwork was mechanically fixed to the structural frame.
- General studwork was installed at 400mm centres.
- Additional studs were installed above door heads to enable plasterboard staggering.
- Additional timber added to base rail for added strengthening.
- Metal stud had been correctly lapped and fixed at corners of door openings.
- Timber was provided at door openings to aide with strengthening as per manufacturers details.

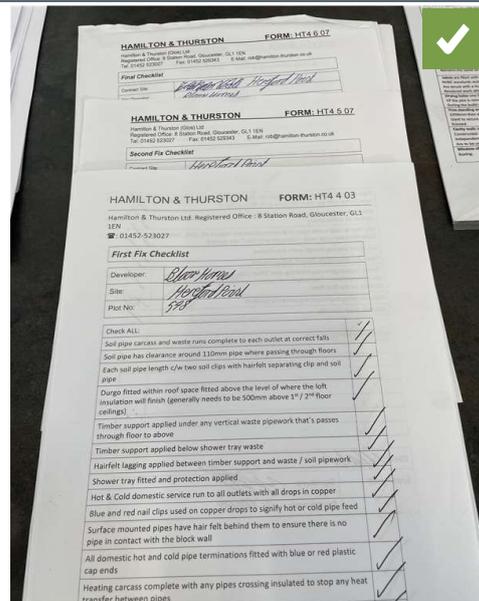
1) Plot No(s): QC documentation

- Quality control documentation was completed and viewed.
- Flue joints were accessible for inspection.
- Boiler pipework had been installed neatly.
- Compression joint for safety valve drain fitted to aid pipe removal during boiler servicing.
- Accessible WC was installed in compliance with Approved Document Part M.
- Sanitaryware was securely installed and neatly aligned.
- Kitchen sink installed parallel to the edge of the worktop.
- Kitchen sink pipework was neatly installed.
- A proprietary isolation valve was installed as per the specifications.
- Shower hose restricted with restraining ring/clip to prevent back flow.
- Radiators were installed within the centre line of the window.

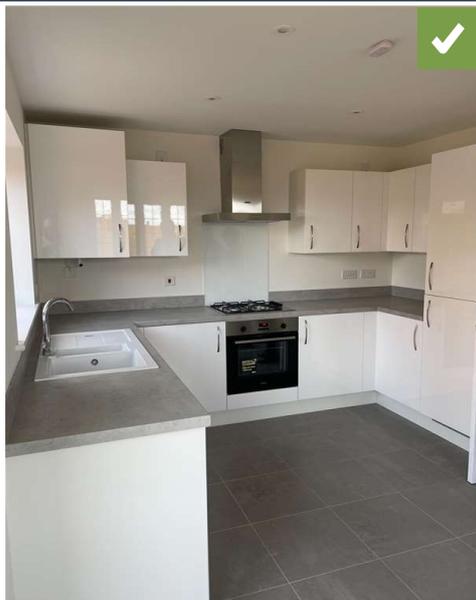
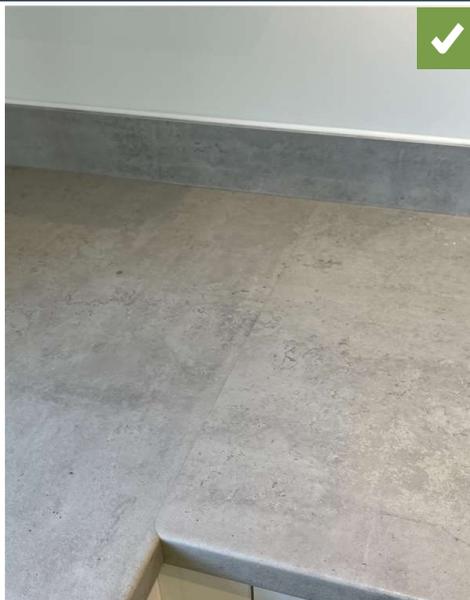
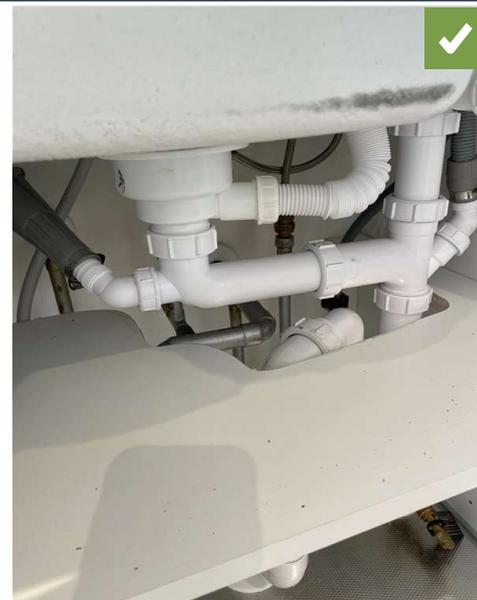
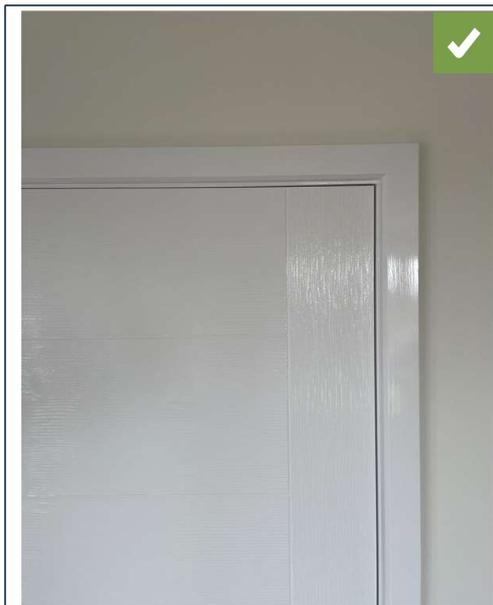
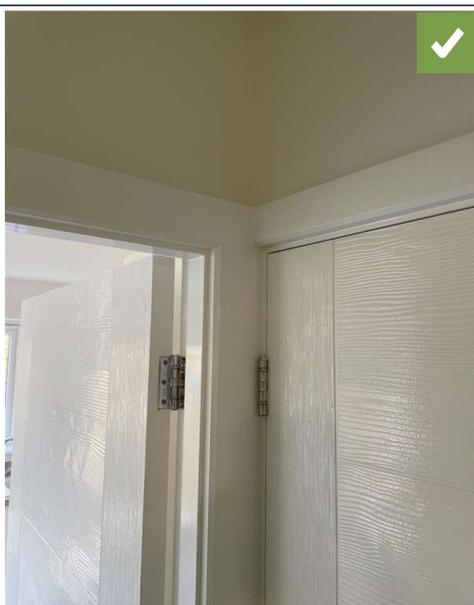
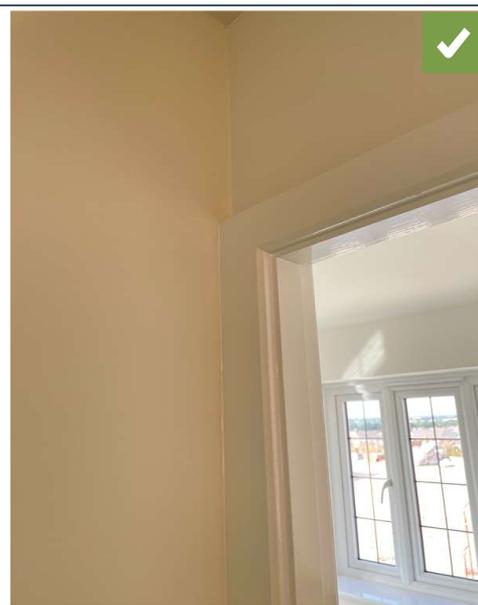
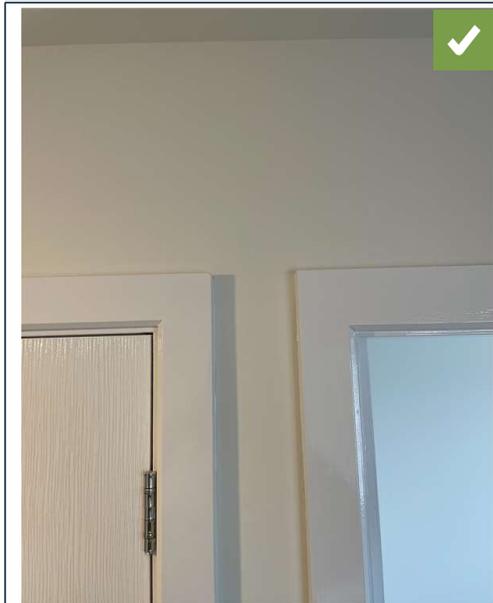
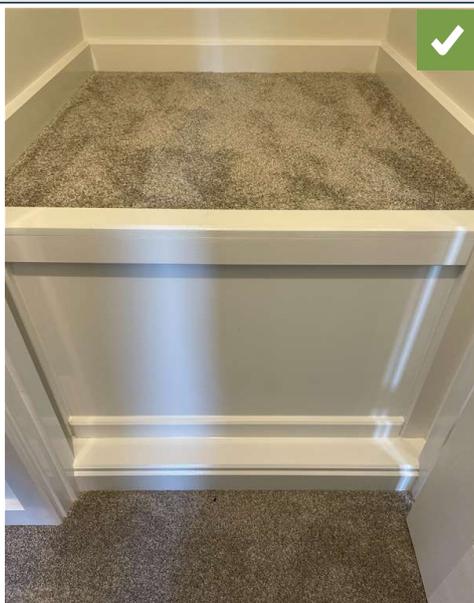
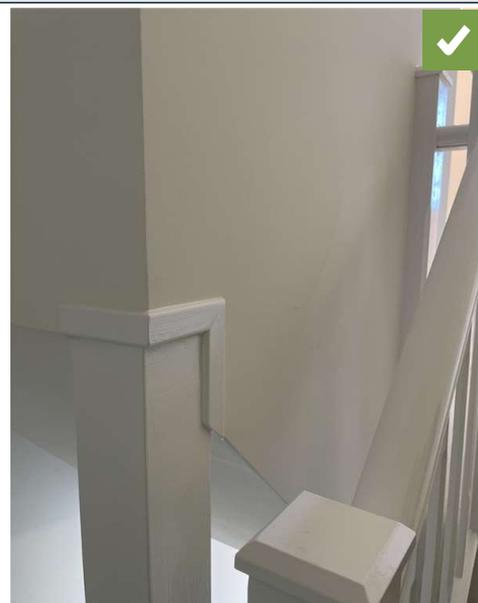
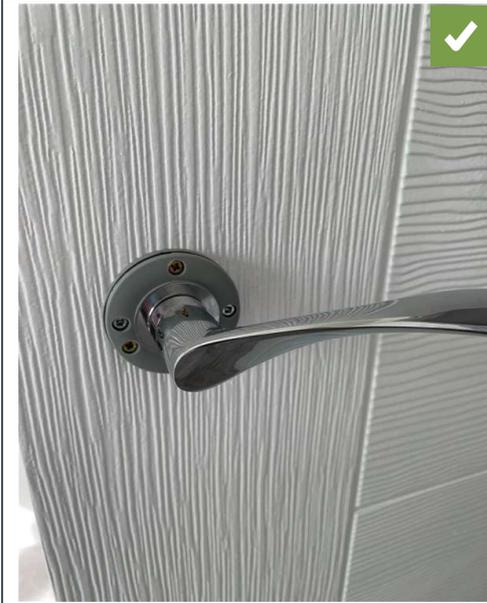
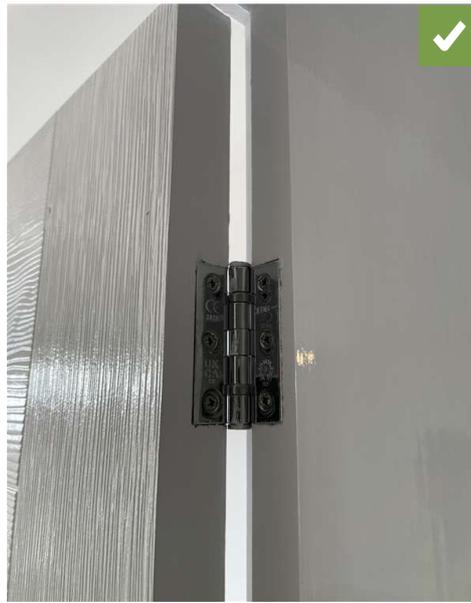
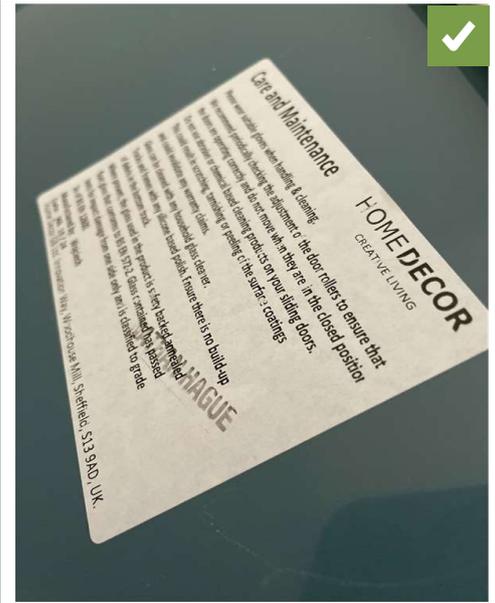
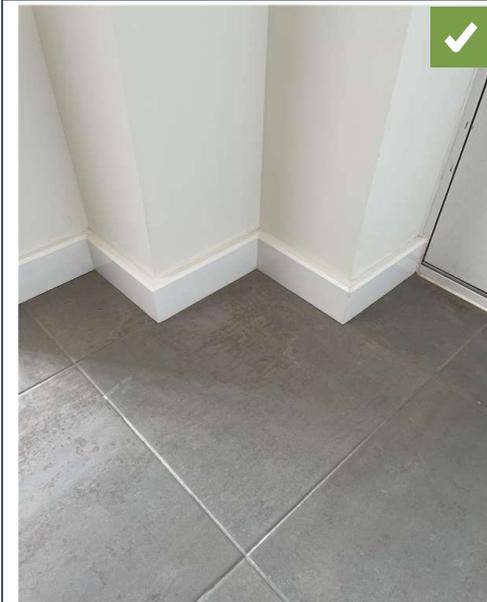
- Kitchen units had been installed securely with a consistent line and level.
- Kitchen worktop mitres were cut with precision, fitting tightly and flush.

- The kitchen unit shelf was neatly formed around the pipework with the cut-out sealed.
- Doors were installed flush with linings, ensuring margins within tolerances.

- Architraves neatly installed to eliminate difficult to paint areas.
- The architrave heads were in line and leveled through.
- A picture frame detail was formed in the airing cupboards.

- Architrave and Skirting was neatly formed to provided excellent detailing.
- Through bolts were fitted to door handles.
- Ironmongery was neatly inset with precise cutting.

- Wardrobes were fitted with safety glass appropriately labelled.
- Mitres and scribes to the skirtings had been accurately cut and installed flush.
- A good level of organisation and storage of materials was viewed in the compound.

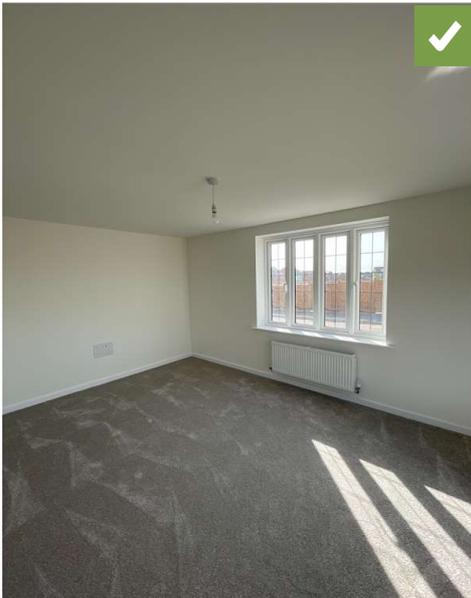
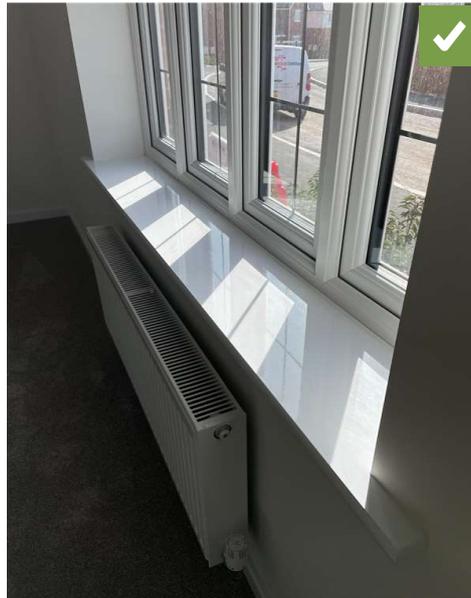
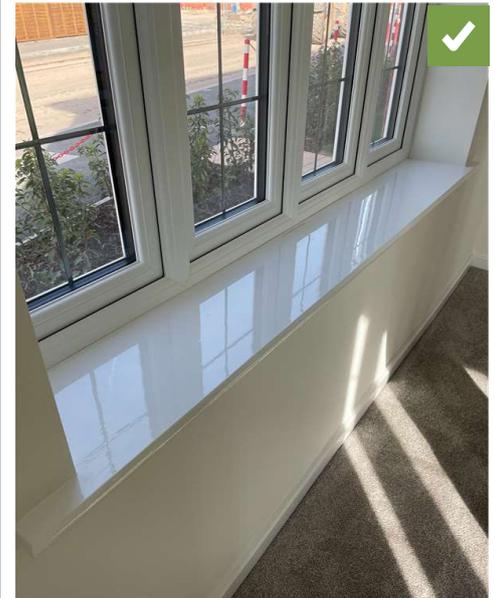
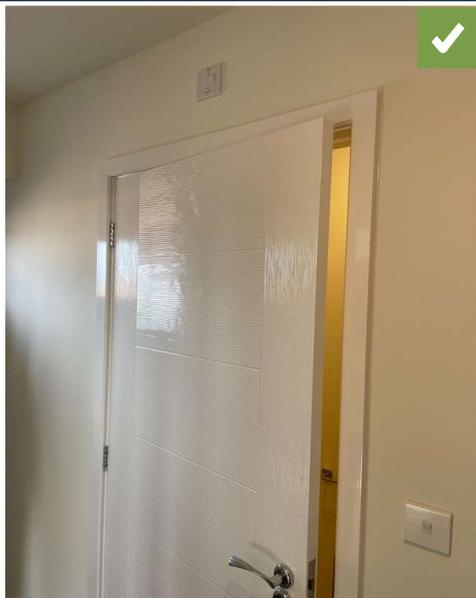
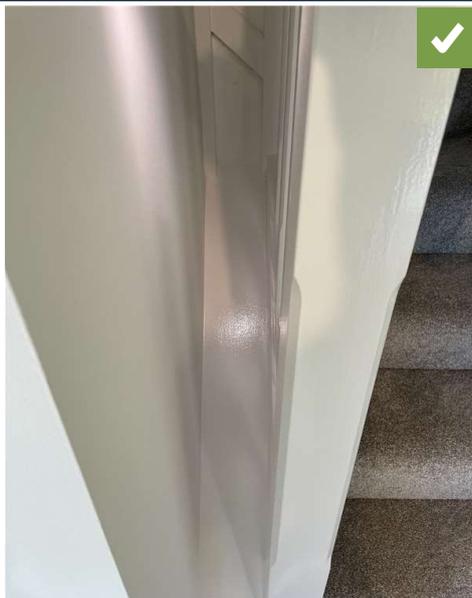
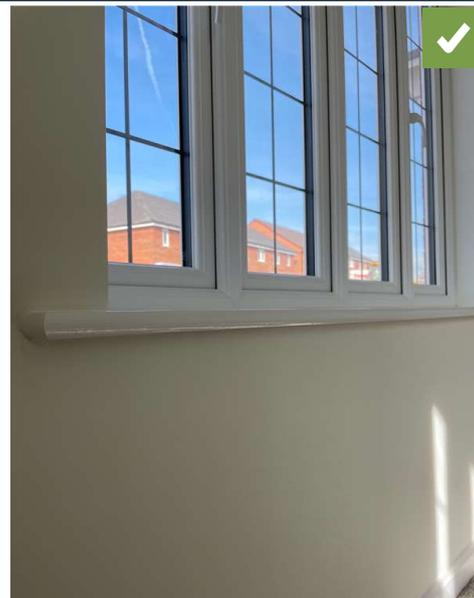
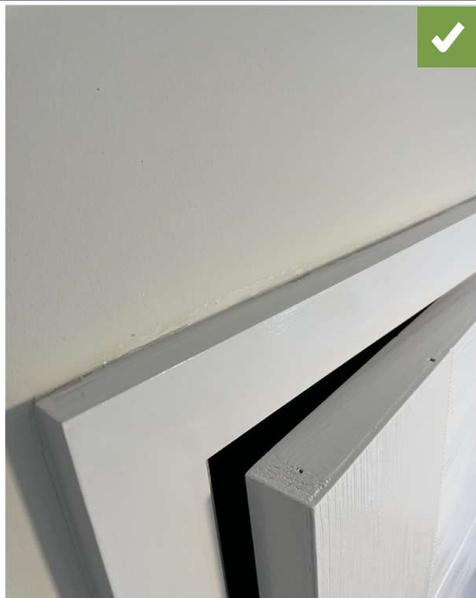
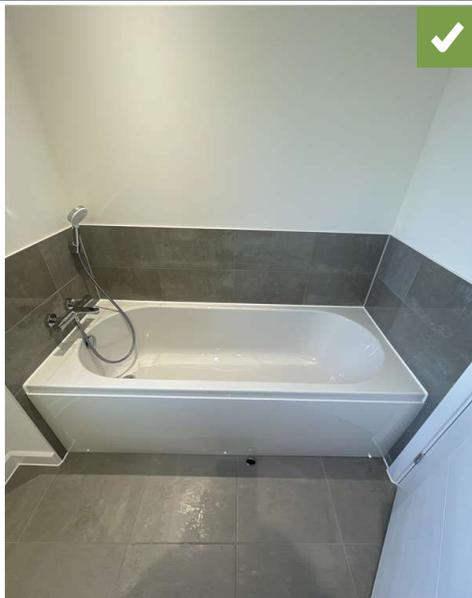
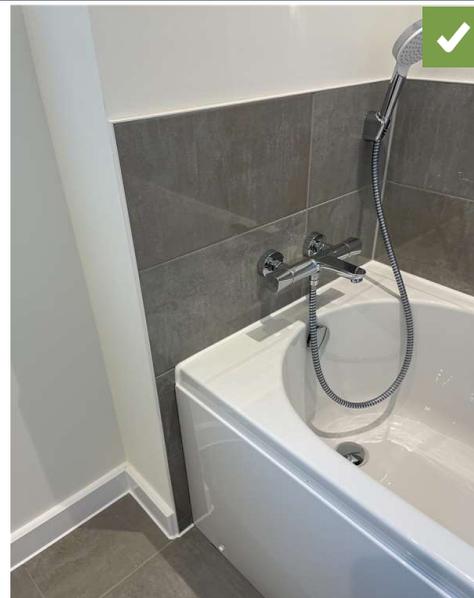
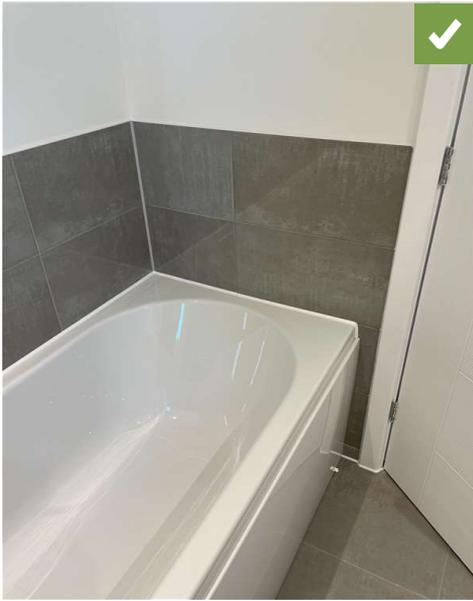
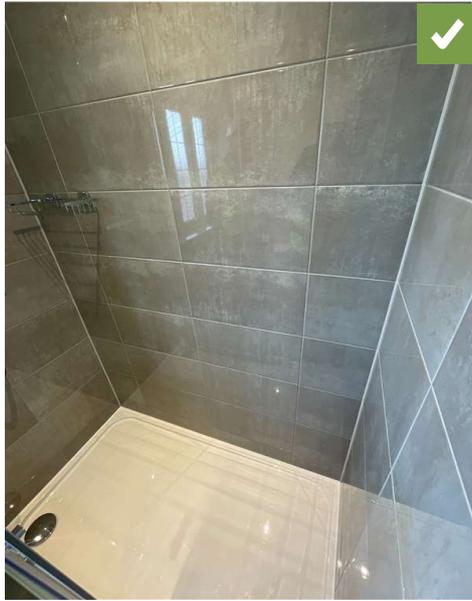
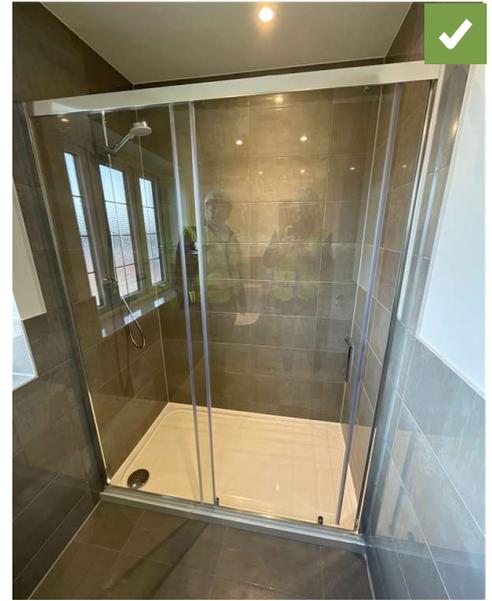
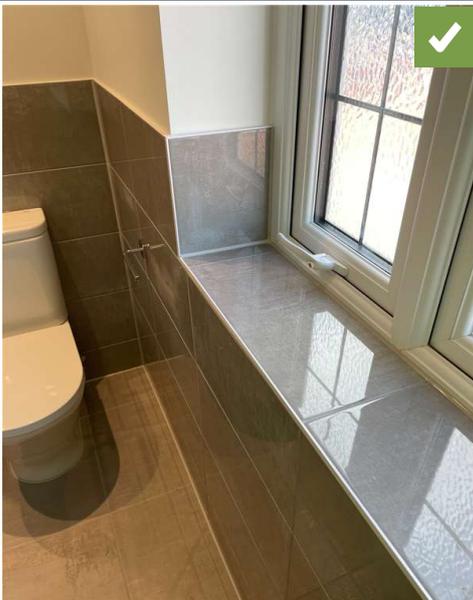
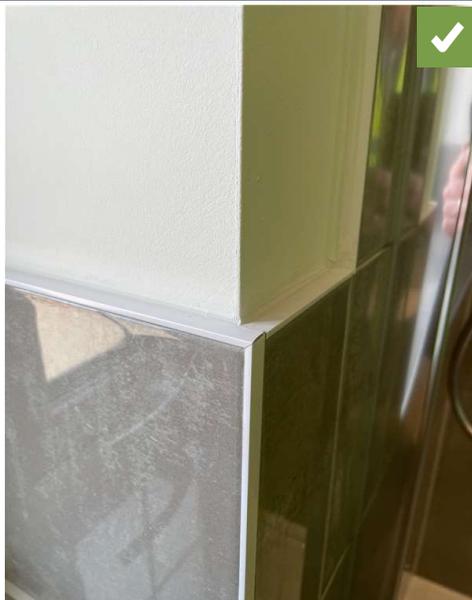
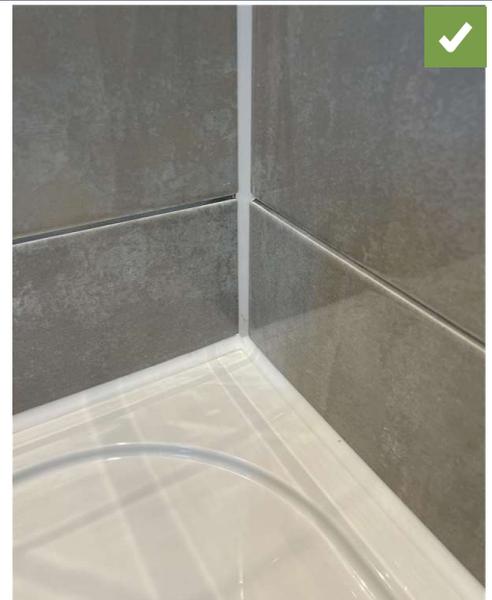
- Clean and crisp lines were maintained at wall/ceiling junctions.
- Decorative finish to walls and ceilings had a consistent and even appearance.
- Finishes were free from conspicuous runs or prominent brush marks.
- The paintwork was of a high quality finish.
- High-quality decoration was below window boards.
- The tops of doors and architraves were glossed.
- Ceramic tiling was level with flush junctions between tiles.
- Grouting was a uniform colour and free from blemishes.
- Setting out of tiling was consistent across areas seen.
- Ceramic tiling continued past the end showers and baths to achieve a better aesthetic finish.
- Tile trims were neatly jointed and flush to tile edges.
- Mastic seals were colour-matched.

- Good - Output from trades / Familiar with what's required
- Good - Site Management / Competent Site Manager / Experienced

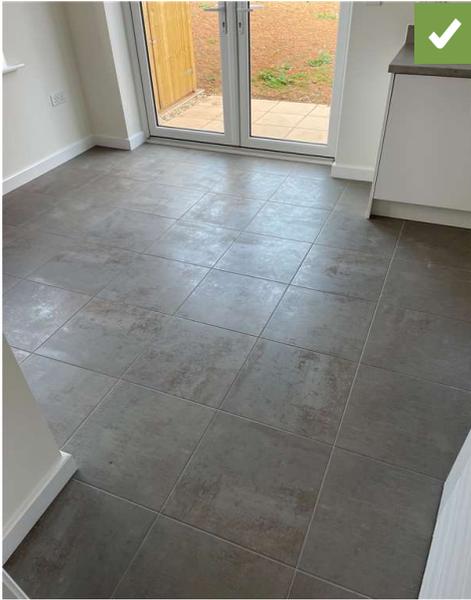
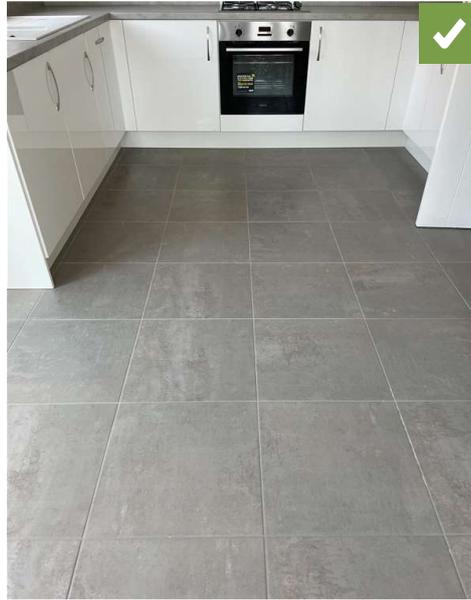
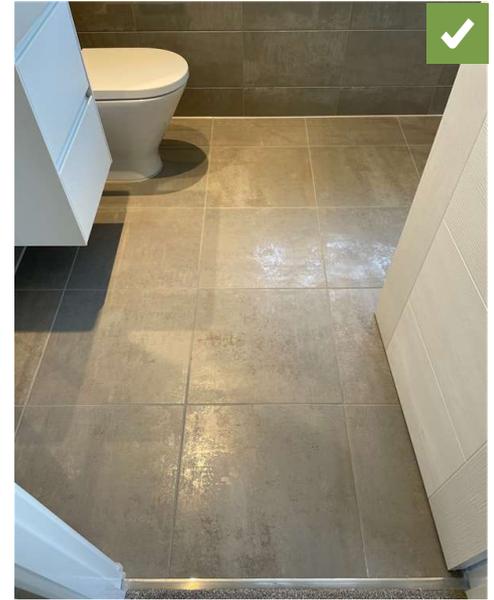
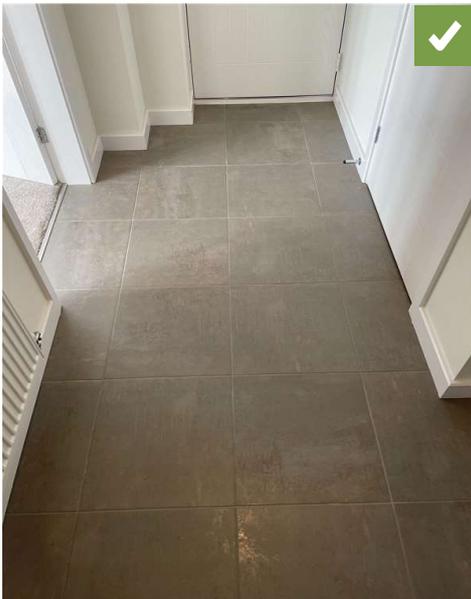
- 1 plot was available and viewed at this build stage, plot 370.
- Component/product/material details: Vinyl flooring / Preparation / Application / Protection / Mastic.
- Contractor details: DCF Flooring (Flooring contractors) / Future Mastic (Mastic applicators)
- Quality was very good and consistent across the plot seen.

- Floor tiling was level with flush edges between tiles.
- Floor tiling was set out to minimise unsightly cuts at the edges.
- Grouting was a uniform colour and free from blemishes.

- Good - Output from trades / Takes pride in work
- Good - Site Management / Site Manager following QA process

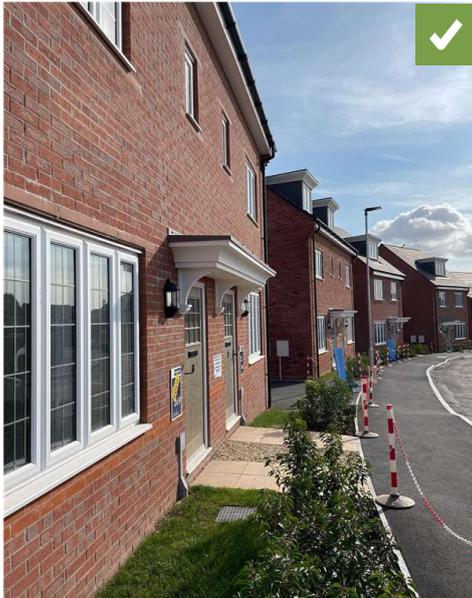
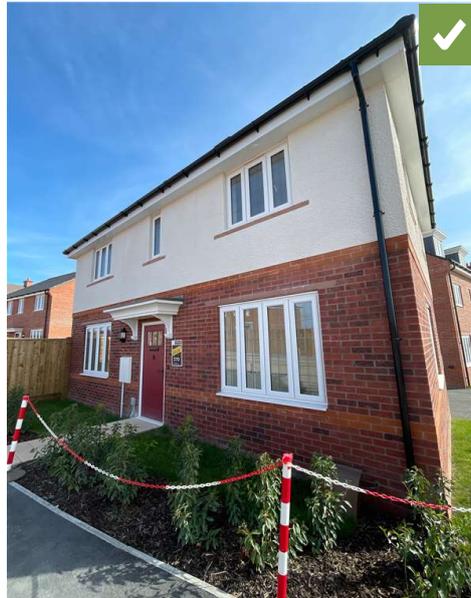
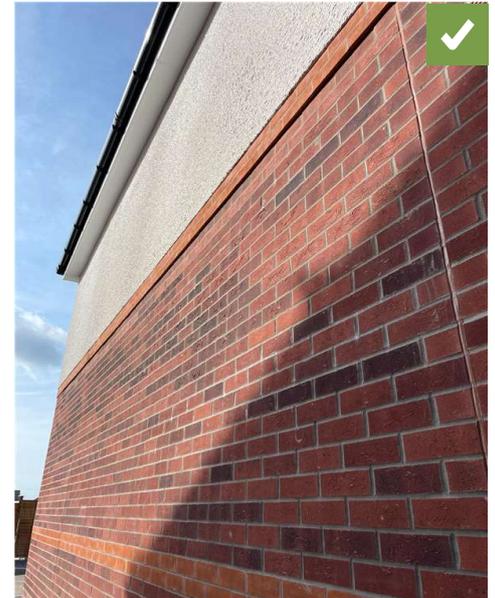
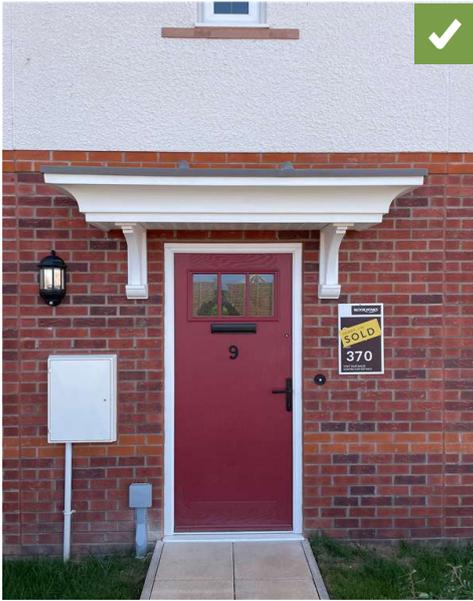
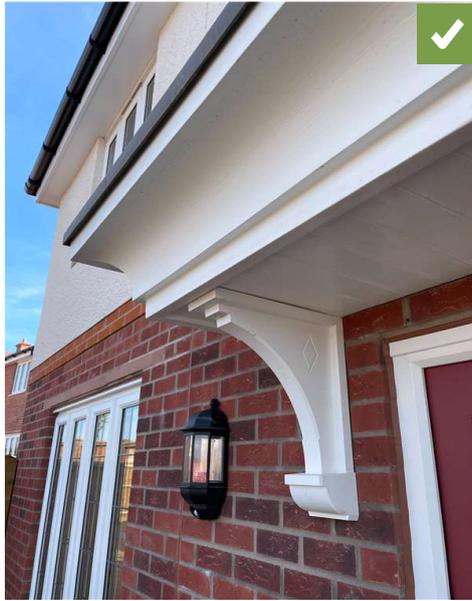
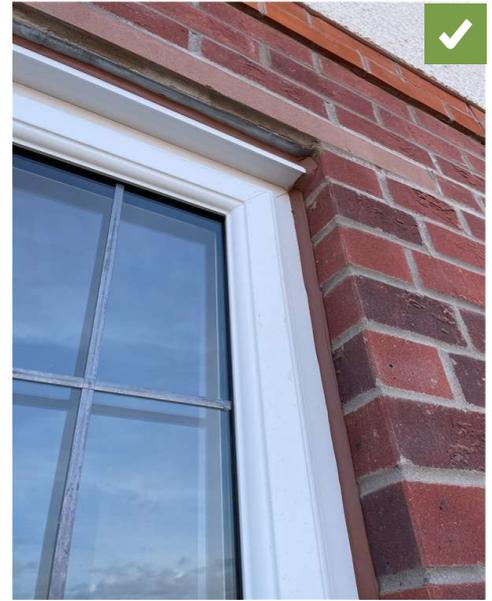
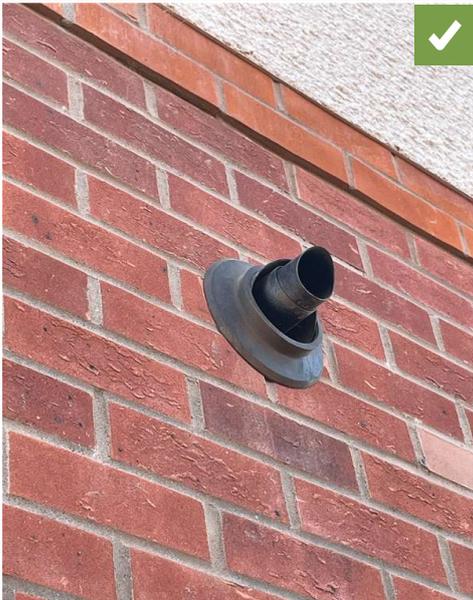
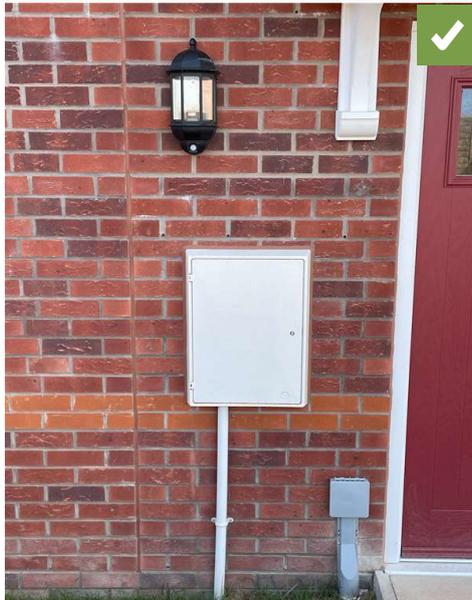
- Multiple plots were available with 7 viewed at this build stage, plots 364, 365, 366-367, 368-369 & 370
- Component/product/material details: External finishes & details.
- Contractor details: Pace Decorating (Decorators).
- Contractor details: Future Mastic (Mastic applicators).
- Contractor details: Malvern Brickwork (Bricklaying contractor).
- Contractor details: Clarkson Evans (Electrical contractor).
- Contractor details: Hamilton & Thurston (Plumbing contractor).
- Quality was very good and consistent across the plot seen.

- Facades and surfaces were clean with a good visual appearance.
- GRP canopies were installed in accordance with BBA certificate/manufacturers guidance.
- Mastic seals were neatly applied with a uniform size of bead.
- Boiler flue correctly sealed with the gasket/proprietary cover fitted tight to external finish.
- Service ducts were installed plumb.
- Service ducts were secured using clips.

- Good - Output from trades / Familiar with what's required
- Good - Site Management / Competent Site Manager / Experienced

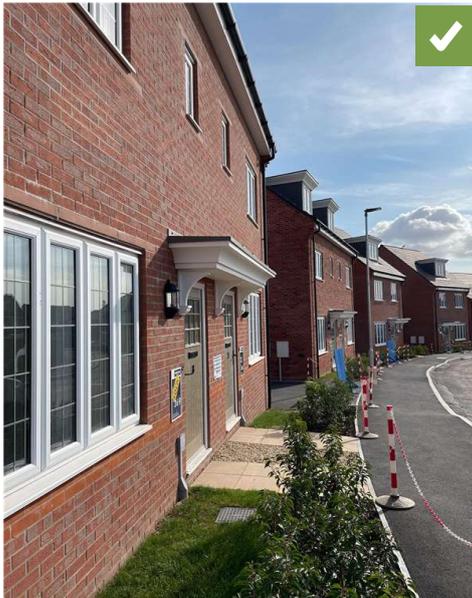
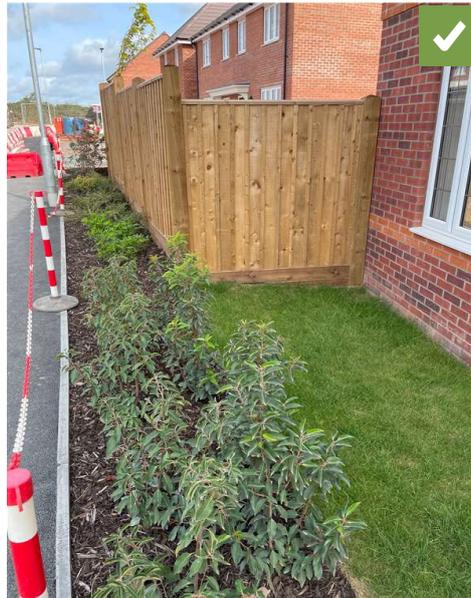
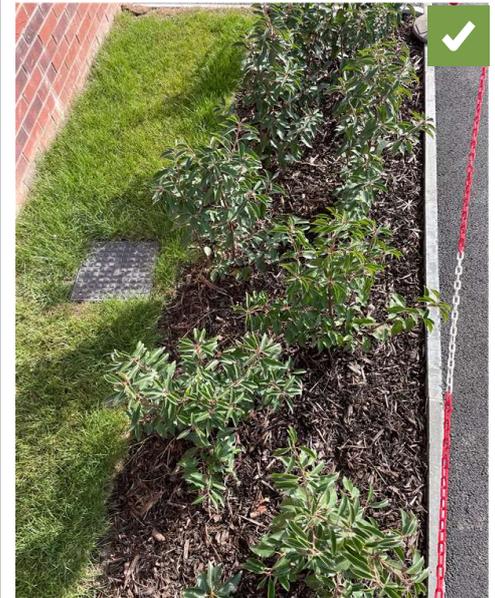
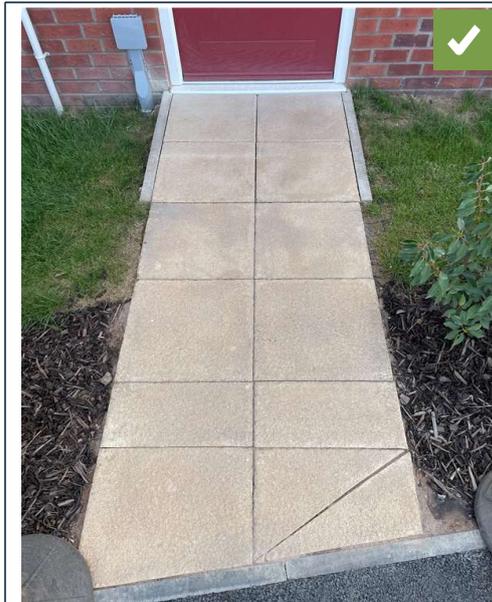
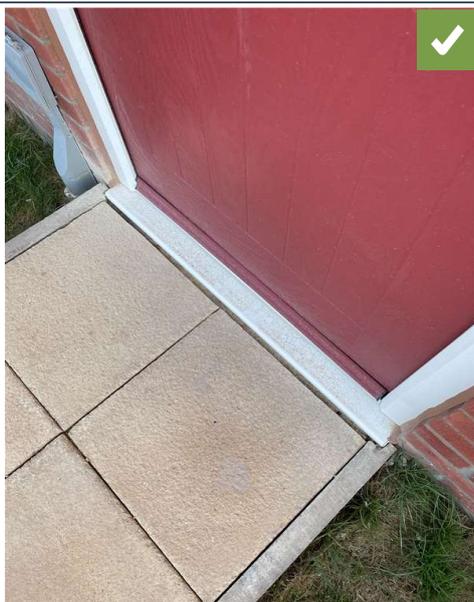
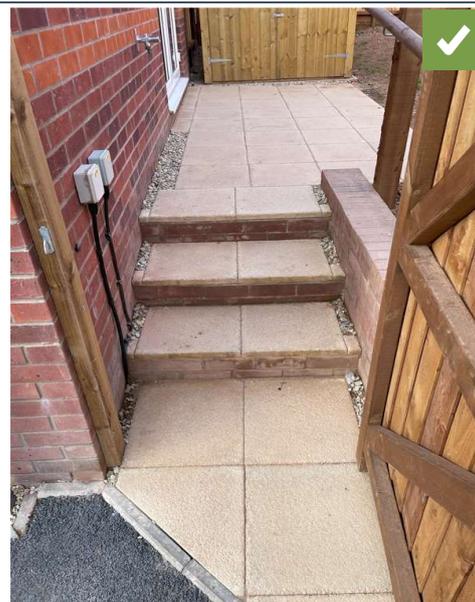
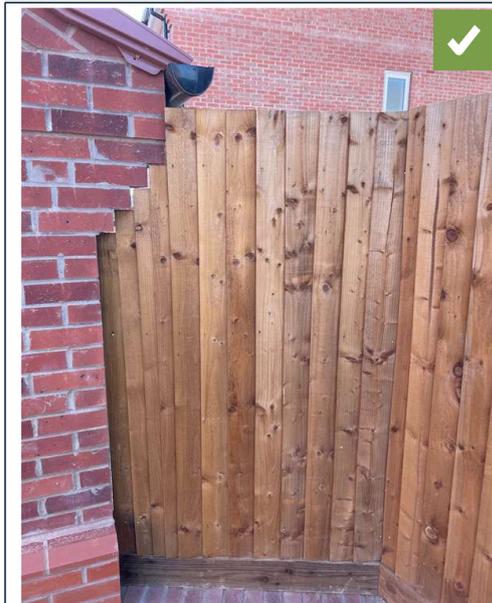
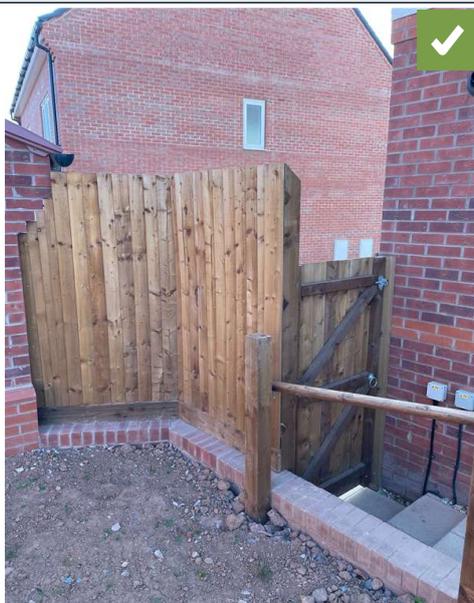
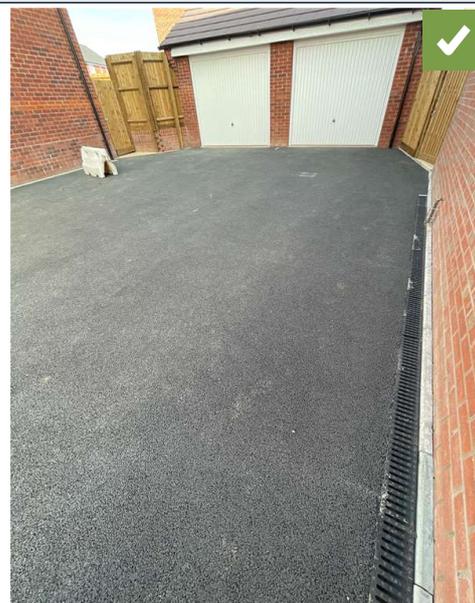
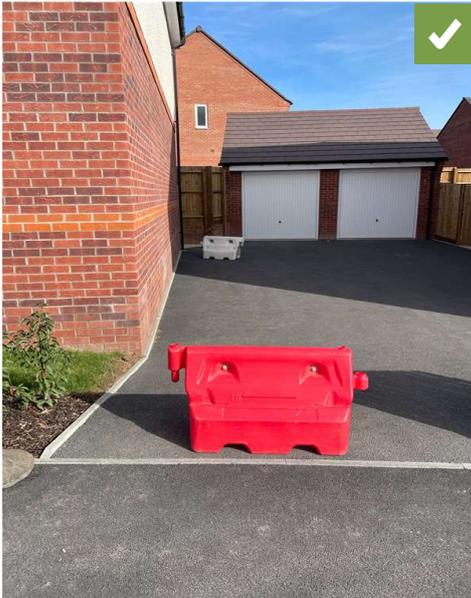
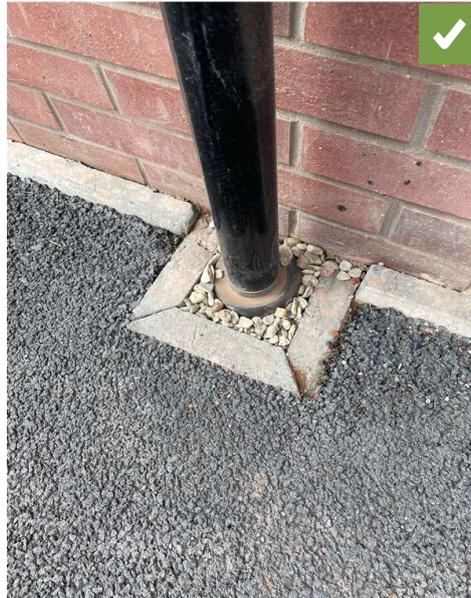
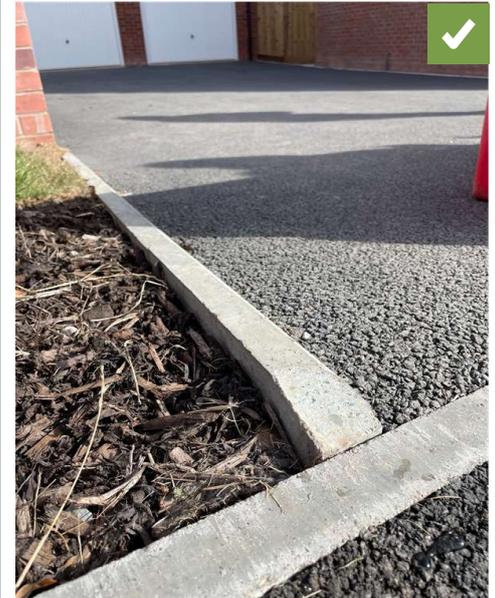
- Multiple plots were available with 7 viewed at this build stage, plots 364, 365, 366-367, 368-369 & 370.
- Component/product/material details: Part M / Paving slabs / Driveways / Turfed areas.
- Contractor details: Westpoint (Groundwork contractors).
- Contractor details: Eric Grabham (Landscaping contractor).
- Quality was outstanding and consistent across the plot seen.

- Landscaping was completed to a good standard.
- Good guidance was provided in the arrangement of the planting areas.
- Part M approach was installed in compliance with NHBC guidance and Approved Document M.
- Drainage slot of 10-18mm was provided to the door threshold.
- Paving slabs were installed to a good line and level.
- Fencing was neatly formed adjacent to the garage wall.
- Tarmac was installed to a consistent and level finish.
- Adequate drainage was provided to the driveway.
- The completed driveways had been protected from unauthorized use.
- Kerb edgings were installed around rainwater pipe entry into drains.
- The kerb edgings were neatly formed at points where there were changes in height.
